RATTLE NOISE FROM INSTRUMENT PANEL AND/OR CREAK NOISE FROM A-PILLAR OVER ROUGH / BUMPY ROADS

Bulletin No: 09-002/14**Last Issued:** 10/03/2014**BULLETIN NOTE**

2013-2015 CX-5 vehicles with VINs of JM3KE*****514170 or lower (produced before July 31, 2014)

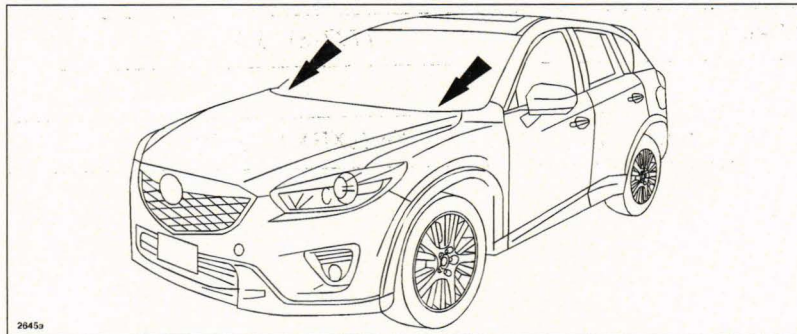
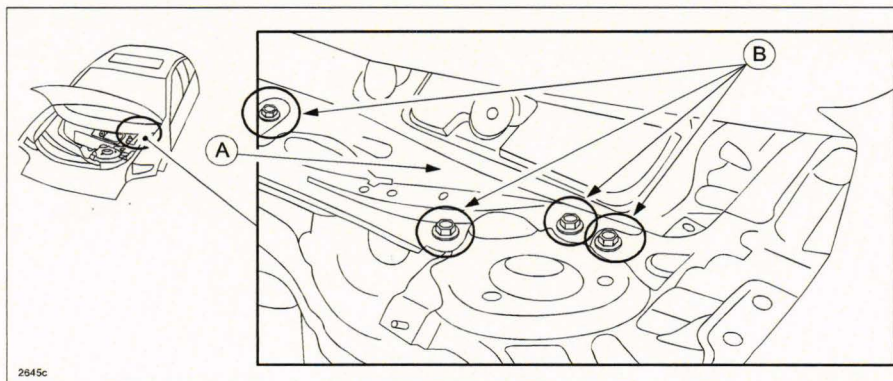
Rattle Noise From Instrument Panel:

The rattle noise may be caused by low cowl panel (A) mounting bolt (B) torque.

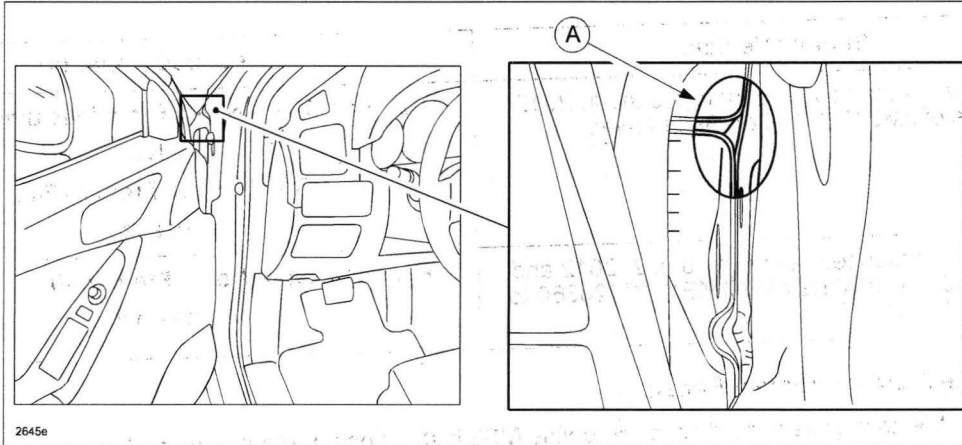
Creak Noise From A-Pillar:

This noise may be caused by two joined panels (A) scraping together at the A-pillar. The panel weld areas have been improved during the mass-production of vehicles with VINs JM3KE*****128359 (produced June 1, 2012) or higher.
