Service Bulletin

Subject: RATTLE NOISE FROM INSTRUMENT PANEL AND/OR CREAK NOISE FROM A-PILLAR OVER ROUGH / BUMPY ROADS	Bulletin No: 09-002/14
	Last Issued: 01/08/2014

2013-2014 CX-5

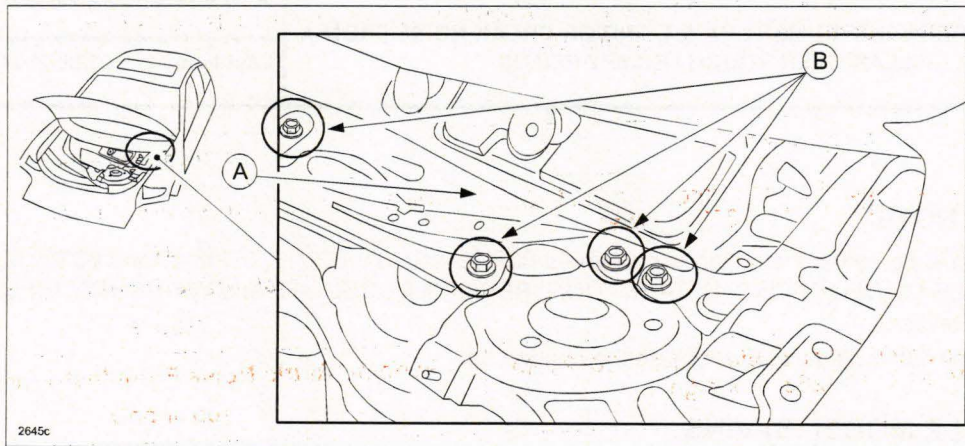
Rattle Noise From Instrument Panel:

The rattle noise may be caused by low cowl panel (A) mounting bolt (B) torque.

2. Retighten all ten (10) cowl panel bolts (A) to:
Tightening Torque: 17-22 ft. lbs {22-30 Nm, 2.3-3.0 kgf-m}
3. Reinstall the cowl grille according to the online MS3 instructions or the Workshop Manual (section 09-16 COWL GRILLE REMOVAL/INSTALLATION).

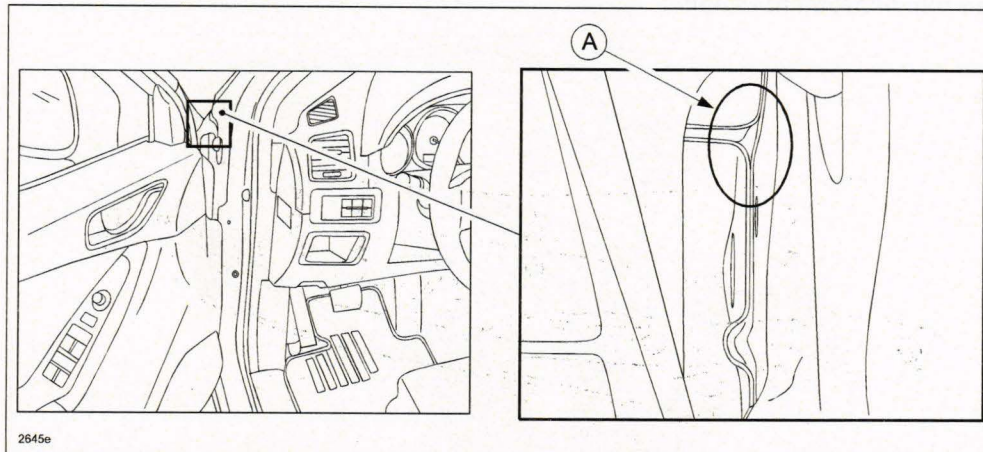
Creak Noise From A-Pillar:

This noise may be caused by two joined panels (A) scraping together at the A-pillar. The panel weld areas have been improved during the mass-production of vehicles with VINs JM3KE*****128359 (produced June 1, 2012) or higher.

Enlarge the clearance between two (2) panels (A) using an appropriate tool (i.e. flat-blade screwdriver).
