<b>Subject:</b> VARIOUS ELECTRICAL SYSTEM MALFUNCTION(S) RELATED TO C-15 CONNECTOR CORROSION	<b>Bulletin No:</b> 09-005/14
	<b>Last Issued:</b> 02/07/2014

2013-2014 CX-5 vehicles with VINs lower than JM3KE\*\*\*\*\*365953 (produced before June 25, 2013)

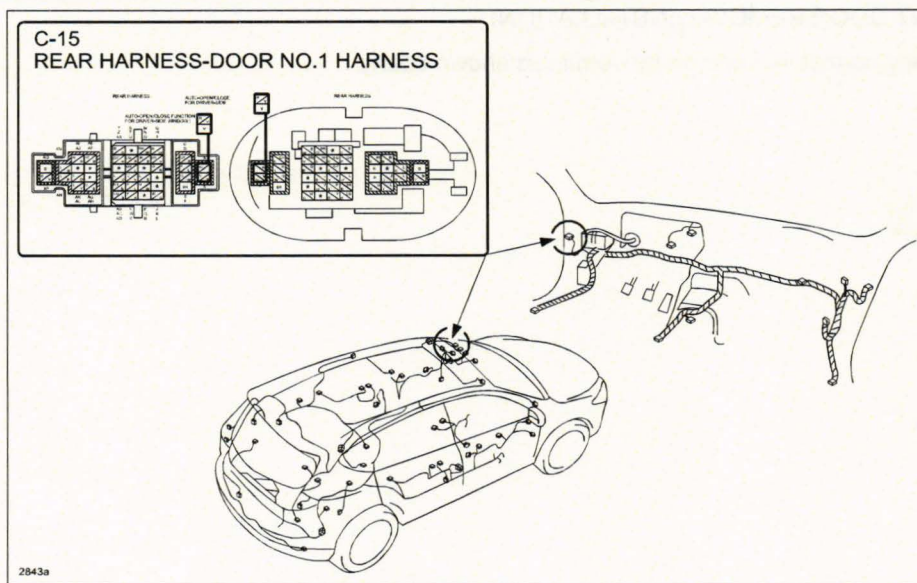
The symptoms listed above may be caused by corrosion of the C-15 connector terminals due to water intrusion through the front door. In low ambient temperatures, the door harness hardens. If the door is fully opened, it may create a gap between the door and the door harness grommet, which may allow water to enter through the gap.

- The front door harness grommet has been changed to improve sealing performance.
- Holes inside the front pillar (which are made for weight reduction), have been covered to prevent water intrusion.

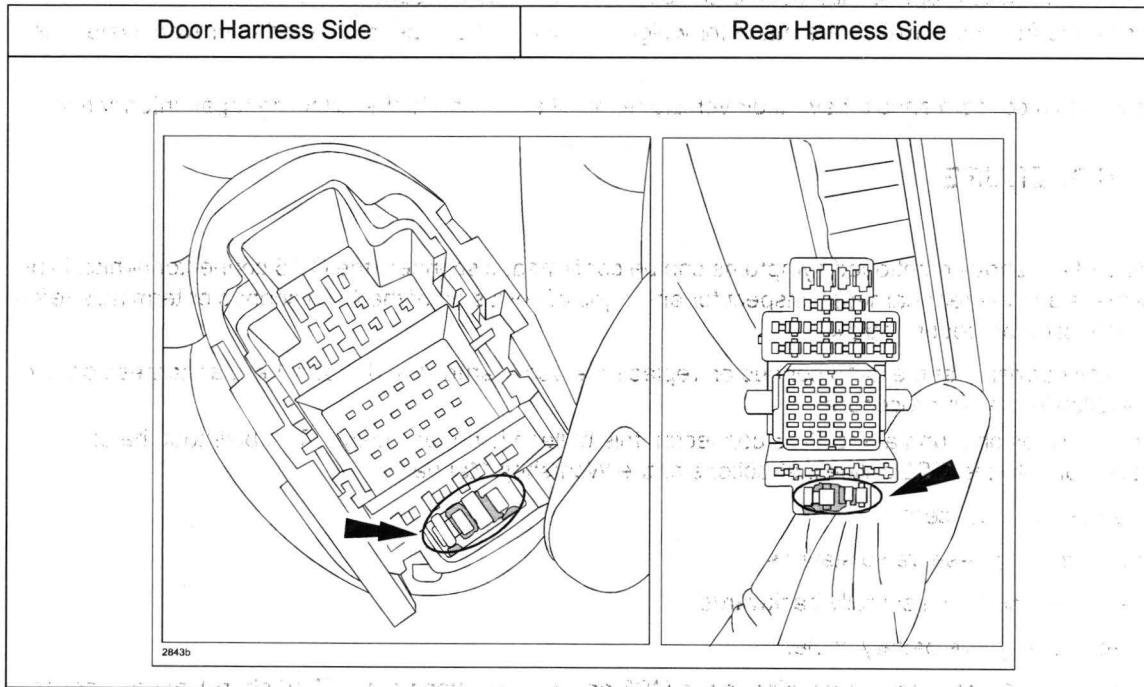
- If there is any corrosion at the C-15 connector, replace the door harness and repair the rear harness according to the following repair procedure.
  - If there is no corrosion found at the C-15 connector, this bulletin is not applicable. Troubleshoot the concern(s) according to the MS3 online instructions or the Workshop Manual.
1. Verify the customer concern.
  2. Record customers pre-set radio stations.
  3. Slide the driver side front seat fully backwards.
  4. Disconnect the negative battery cable.
  5. Disconnect the C-15 connector according to the MS3 online instructions or the Workshop Manual (section 09-11 FRONT DOOR REMOVAL/INSTALLATION).
  6. Inspect for any corrosion found on the terminals shown below.

- If there is any corrosion found on the terminals, go to next step.
  - If there is no corrosion found on the terminals, this bulletin is not applicable. Troubleshoot the concern(s) according to the MS3 online instructions or the Workshop Manual.
7. Remove the driver-side front side trim according to the MS3 online instructions or the Workshop Manual (section 09-17 FRONT SIDE TRIM REMOVAL/INSTALLATION).
  8. Remove the hood release lever from the under panel according to the MS3 online instructions or the Workshop Manual (section 09-14 HOOD LATCH AND RELEASE LEVER REMOVAL/INSTALLATION).
