09-009/14 – 2014 MAZDA3 - COMMANDER SWITCH DROPS INTO CENTER CONSOLE

Subject: COMMANDER SWITCH DROPS INTO CENTER CONSOLE	Bulletin No: 09-009/14
	Last Issued: 01/28/2014

2014 Mazda3 with VINs lower than JM1BM*****142131 (produced before November 6, 2013)

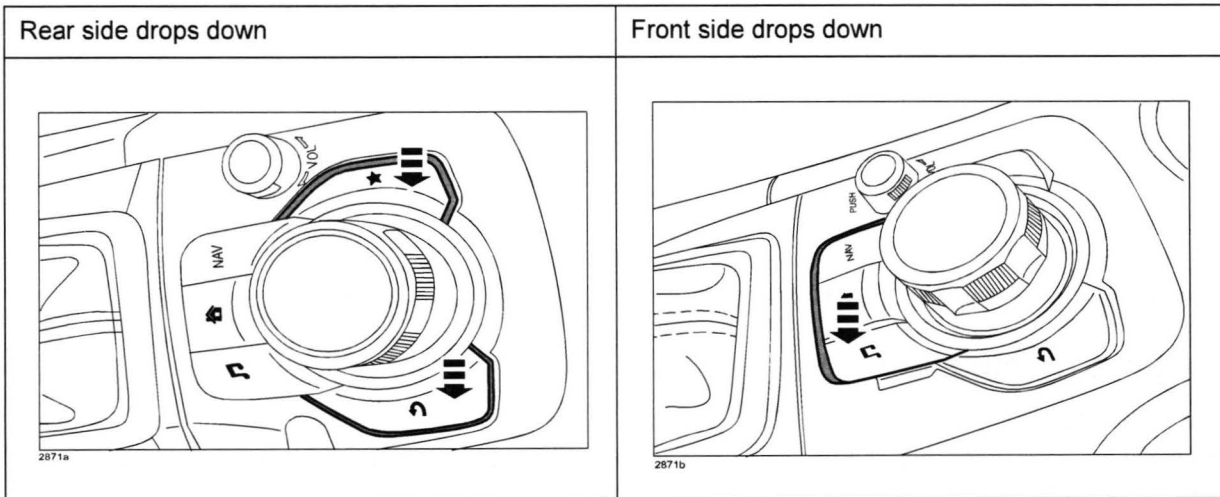
Some vehicles may experience a condition where the commander switch drops down from the panel.

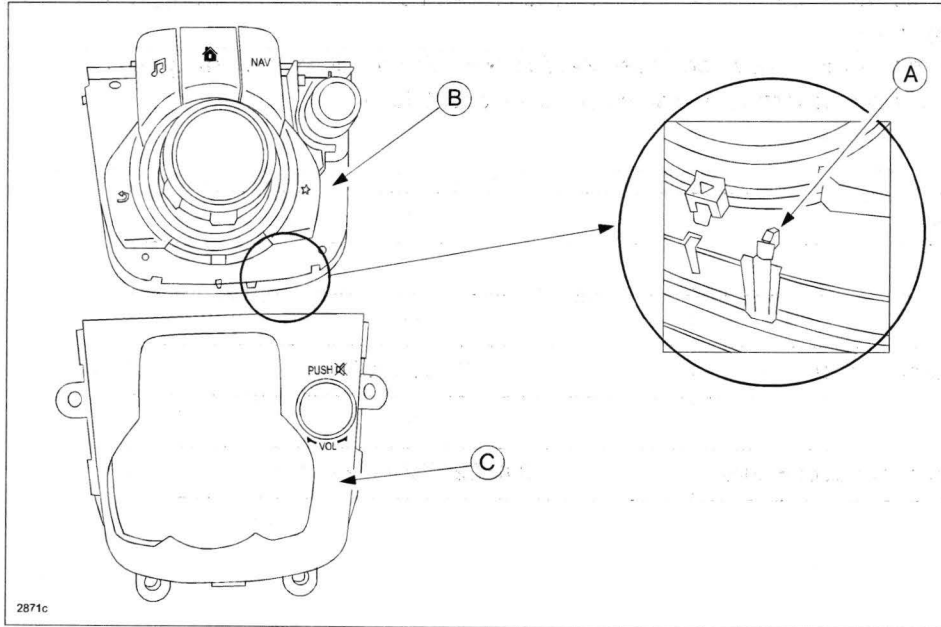
Damage to the hook(s) (A) securing the commander switch (B) to the frame (C) is caused by an excessive vertical force. To correct the problem, pieces of non-woven fabric have been added to the commander switch to increase the load capacity.

1. Verify customer concern.
2. Replace the commander switch with a modified one according to the instructions on MS3 online or the Workshop Manual (section 09-20 COMMANDER SWITCH REMOVAL/INSTALLATION).
3. Verify repair.
