From: Chris Ciz
Sent: Friday, February 21, 2014 1:17 PM
To: All Dirs All Rgns - PT; All Dirs All Rgns - SR
Subject: MAZDA DEALER NOTICE - SERVICE BULLETIN RELEASE

09-013/14 – MULTI-MODEL - BUZZING NOISE FROM STEERING COLUMN

Subject: BUZZING NOISE FROM STEERING COLUMN	Bulletin No: 09-013/14
	Last Issued: 02/21/2014

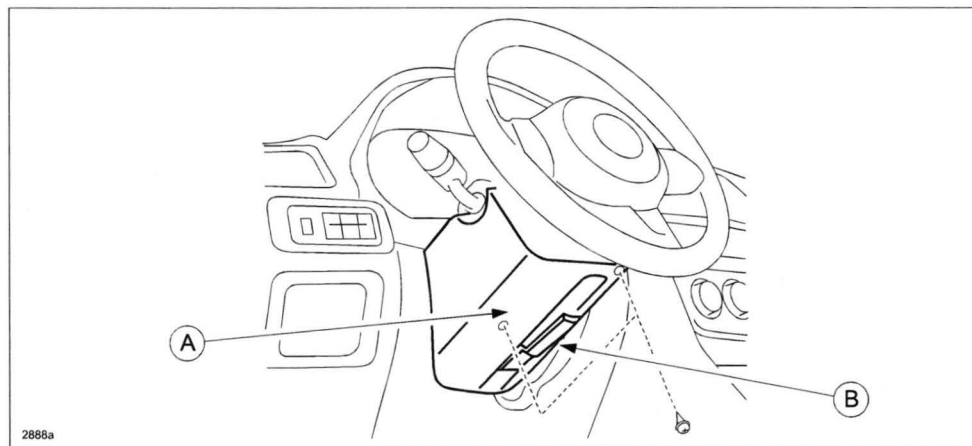
Some vehicles may experience a buzzing noise from the steering column when driving on rough roads or passing over speed bumps. This buzzing noise may be caused by the lower steering column cover (A) contacting the steering wheel adjustment lock lever (B). To correct the problem, felt is attached to the steering column cover.

Customers having this concern should have their vehicle repaired using the following repair procedure.

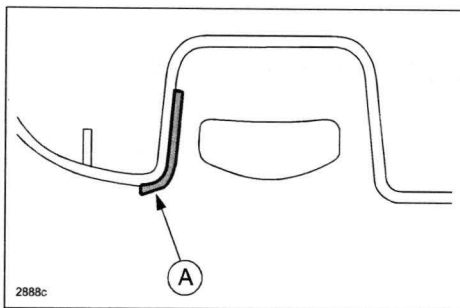
A-A cross section (Felt A)

A: End of edge

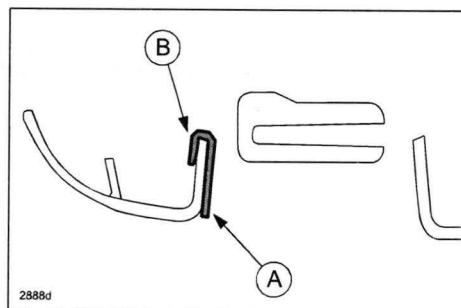
B-B cross section (Felt B)

A: End of edge; B: Fold back tip of the felt
