Service Bulletin

RUST ON BOTTOM OF REAR DOOR GLASS GUIDE

Bulletin No: 09-014/14

2010-**2013** Mazda3 (including Mazdaspeed3)

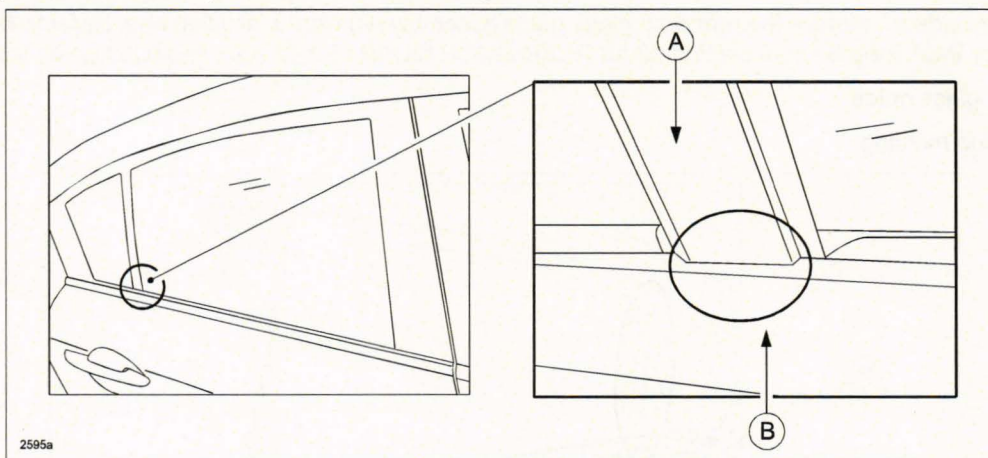
Some vehicles may exhibit rust on the bottom of the rear door glass guide (A) from contact with the rear beltline molding (B). This is caused by a vibration while driving.

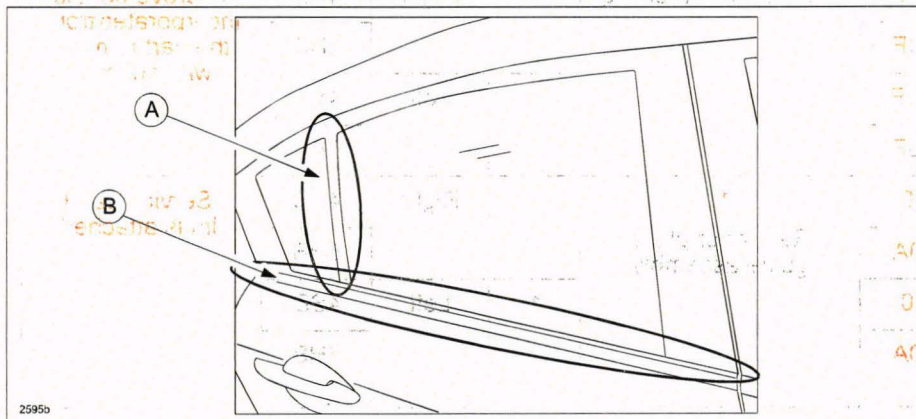
A: Rear door glass guide

B: Rear beltline molding

At the affected side(s), replace both the the rear door glass guide assembly and the rear beltline molding with modified ones. Refer to MS3 online instructions or Workshop Manual section 09-12 REAR DOOR QUARTER GLASS REMOVAL/INSTALLATION and 09-16 REAR BELTLINE MOLDING REMOVAL/INSTALLATION.

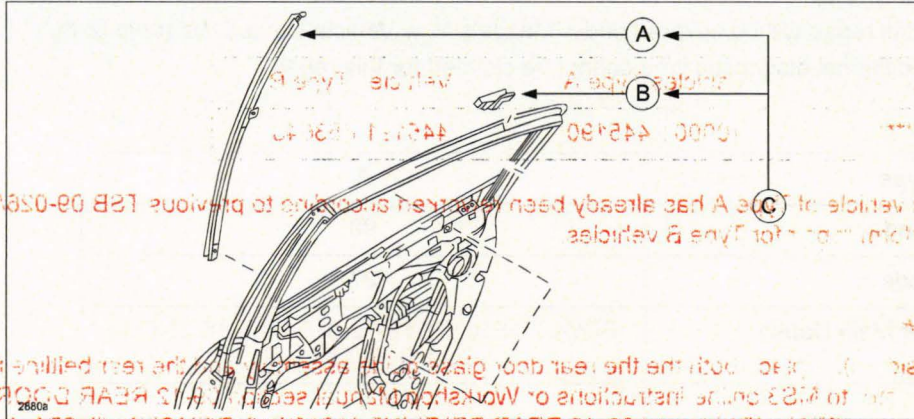
A: Rear door glass guide (film is attached)

B: Protector (current part)

C: Rear door glass guide assembly (service part)

At the affected side(s), replace the rear door glass guide assembly (C) with a modified one. Refer to MS3 online instructions or Workshop Manual section 09-12 REAR DOOR QUARTER GLASS REMOVAL/INSTALLATION.
