From: Daniel Gonzalez
Sent: Tuesday, February 25, 2014 2:52 PM
To: All Dlr's All Rgns - PT; All Dlr's All Rgns - SR
Subject: MAZDA DEALER NOTICE - SERVICE BULLETIN RELEASE

SERVICE BULLETIN RELEASE - 02/25/2014

HOOD VIBRATION ABOVE 68 MPH

Bulletin No: 09-015/14

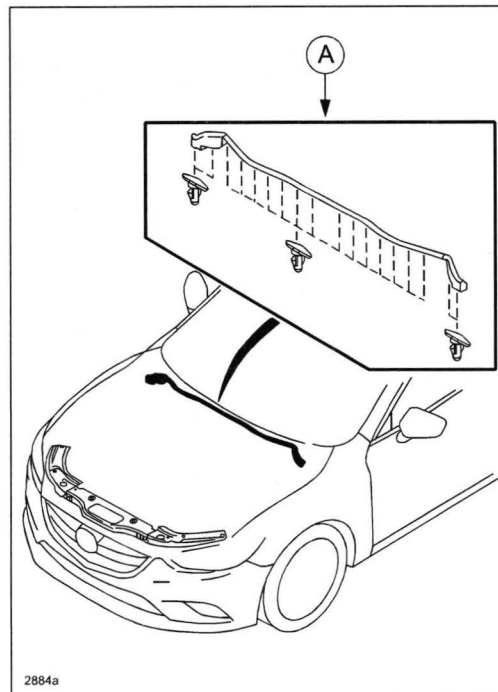
Some vehicles may exhibit a hood vibration when driving above 68 mph (110Km/h). This may be caused by a cowl grill that is not firmly attached.

NOTE: The cowl grill seal is attached to the cowl grill with clips.

1. Verify customer concern.
2. Replace the cowl grill seal (A). Refer to MS3 online or Workshop Manual (section 09-16 COWL GRILLE REMOVAL/INSTALLATION).

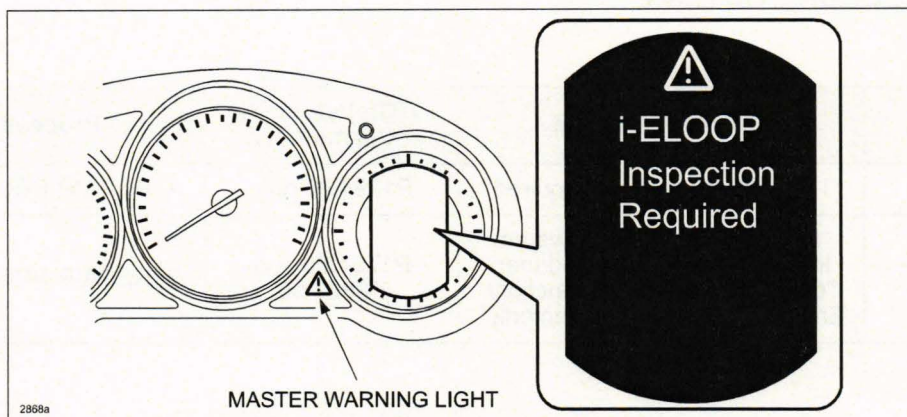
- a. Warning message "i-ELOOP Inspection Required" is displayed in the instrument cluster information display while driving.
- b. The Master warning light will be illuminated.

- c. DTC P1794:00 (Capacitor (i-ELOOP) system: Capacitor (i-ELOOP) malfunction) will be stored in PCM memory.

Customers having this concern should have their vehicle repaired using A. REPAIR PROCEDURE.

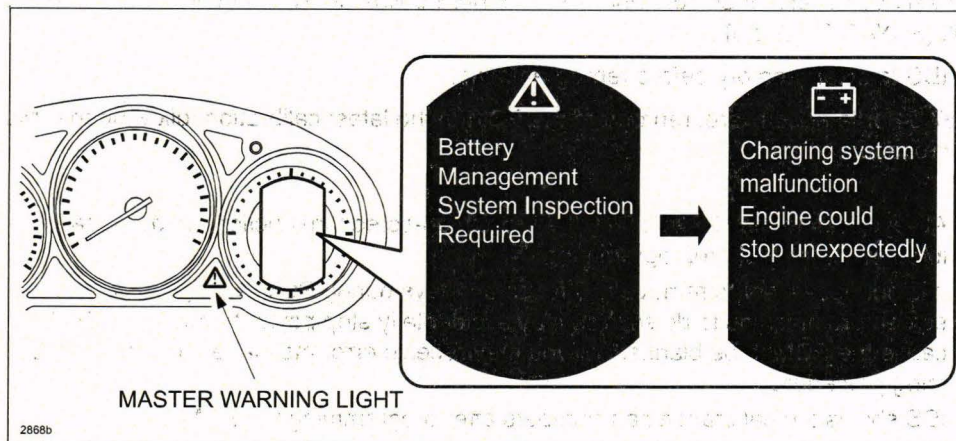
- Warning message "Battery Management System Inspection Required" and then "Charging System Malfunction/Engine could stop unexpectedly" is displayed in the instrument cluster information display after driving in the rain.
- The Master warning light will be illuminated. **The Mazda6 warning indicator light and warning messages are shown below:**

- The following DTCs are stored in PCM memory:
 - DTC P1794:00 - Capacitor (i-ELOOP) system: Capacitor (i-ELOOP) malfunction
 - DTC P2502:00 - Generator system: Malfunction in voltage generated by generator

Customers having this concern should have their vehicle repaired using B. REPAIR PROCEDURE.
