Subject: RATTLE NOISE FROM FRONT DOOR GLASS	Bulletin No: 09-017/14
	Last Issued: 03/05/2014

2013-2014 CX-5 vehicles with VINs lower than **JM3KE*****433172** (produced before January 13, 2014)

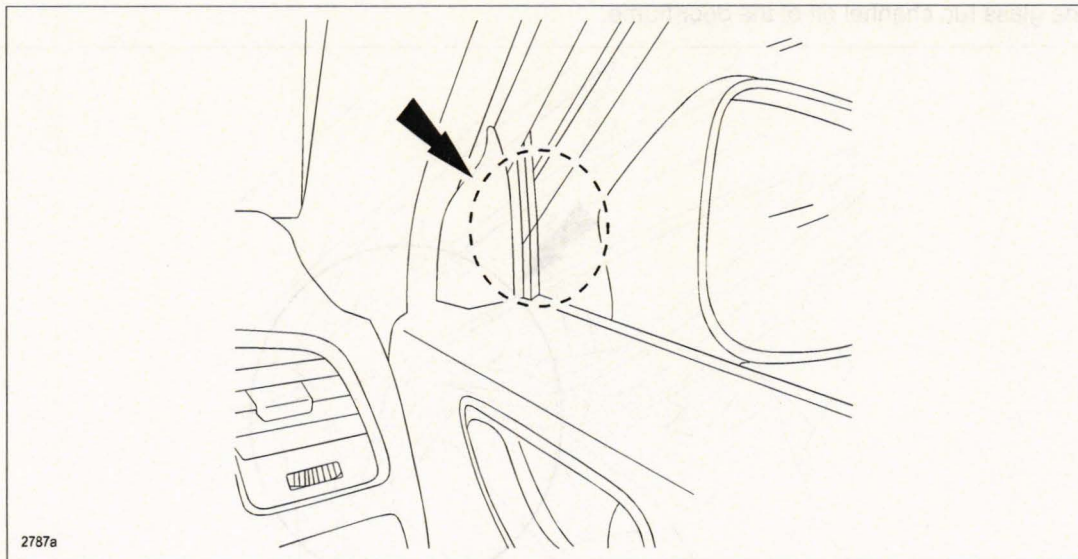
Some vehicles may experience a rattle noise from the front door glass when driving with the window open approx. 1/2 to 4 inches (1 - 10 cm).

The rattle noise may be caused by insufficient glass run channel holding force. To eliminate this concern, the shape of glass run channel has been changed in order to increase the holding force.

Customers having this concern should have their vehicle repaired using the following repair procedure.
