### **SERVICE BULLETIN RELEASE - 08/18/2014**

# Service Bulletin

**RATTLE NOISE FROM FRONT DOOR GLASS**

**Bulletin No:** 09-017/14**Last Issued:** 08/18/2014**BULLETIN NOTE**

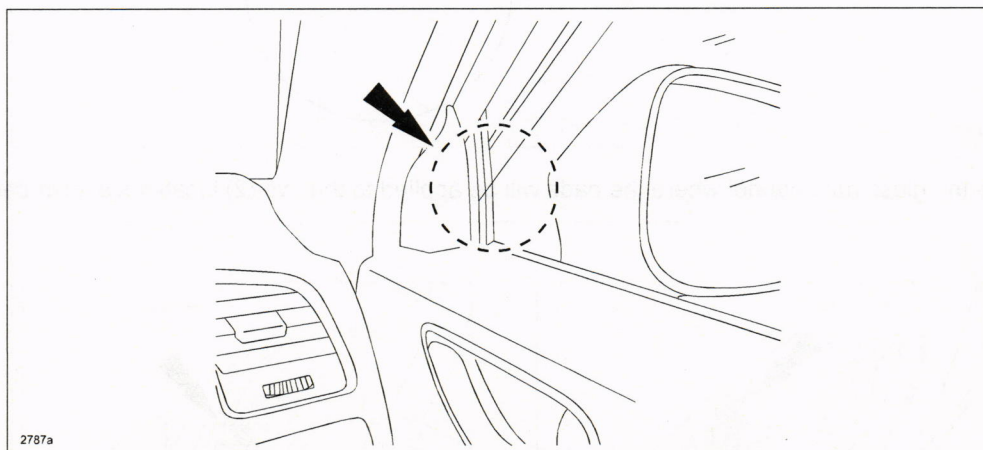
Some vehicles may experience a rattle noise from the front door glass when driving with the window open approx. 1/2 to 4 inches (1 - 10cm).

The rattle noise may be caused by insufficient glass run channel holding force. To eliminate this concern, the shape of glass run channel has been changed in order to increase the holding force.

Customers having this concern should have their vehicle repaired using the following repair procedure.
