# Service Bulletin

VARIOUS AUDIO SYSTEM CONCERNS WITH TUNER AND AMP UNIT (TAU)

**Bulletin No:** 09-021/14

2014 Mazda3 vehicles (with MAZDA CONNECT) with VINs lower than JM1BM\*\*\*\*\*194012 (produced before March 17, 2014)

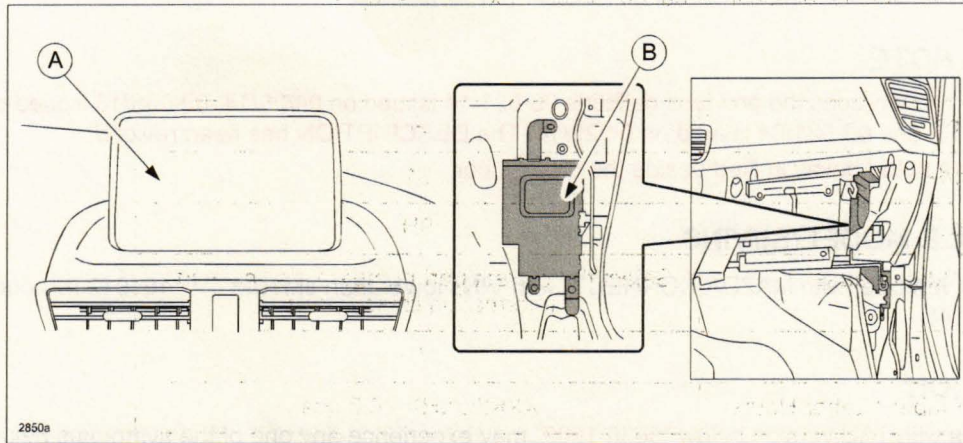
Some vehicles with TAU version below "3030 1903" may experience any one of the symptoms below that can be resolved with a modified TAU.

- AM/FM/XM cannot be selected as they are grayed out
- Radio station returns to 87.9MHz on its own
- Audio sound setting resets on its own
- TAU version is displayed as "not available"
- Volume of FM stations changes while driving when there is poor reception

1. Verify customer concern.
2. On vehicle with a touchscreen (A), remove the TAU (B) and replace with a modified one. Refer to MS3 online instructions or Workshop manual (section 09-20 TUNER AND AMP UNIT (TAU) REMOVAL/INSTALLATION).
