### **SERVICE BULLETIN RELEASE - 05/20/2014**

**MULTIPLE ELECTRICAL MALFUNCTIONS AFTER BODY REPAIR**

**Bulletin No:** 09-022/14

**Last Issued:** 05/20/2014

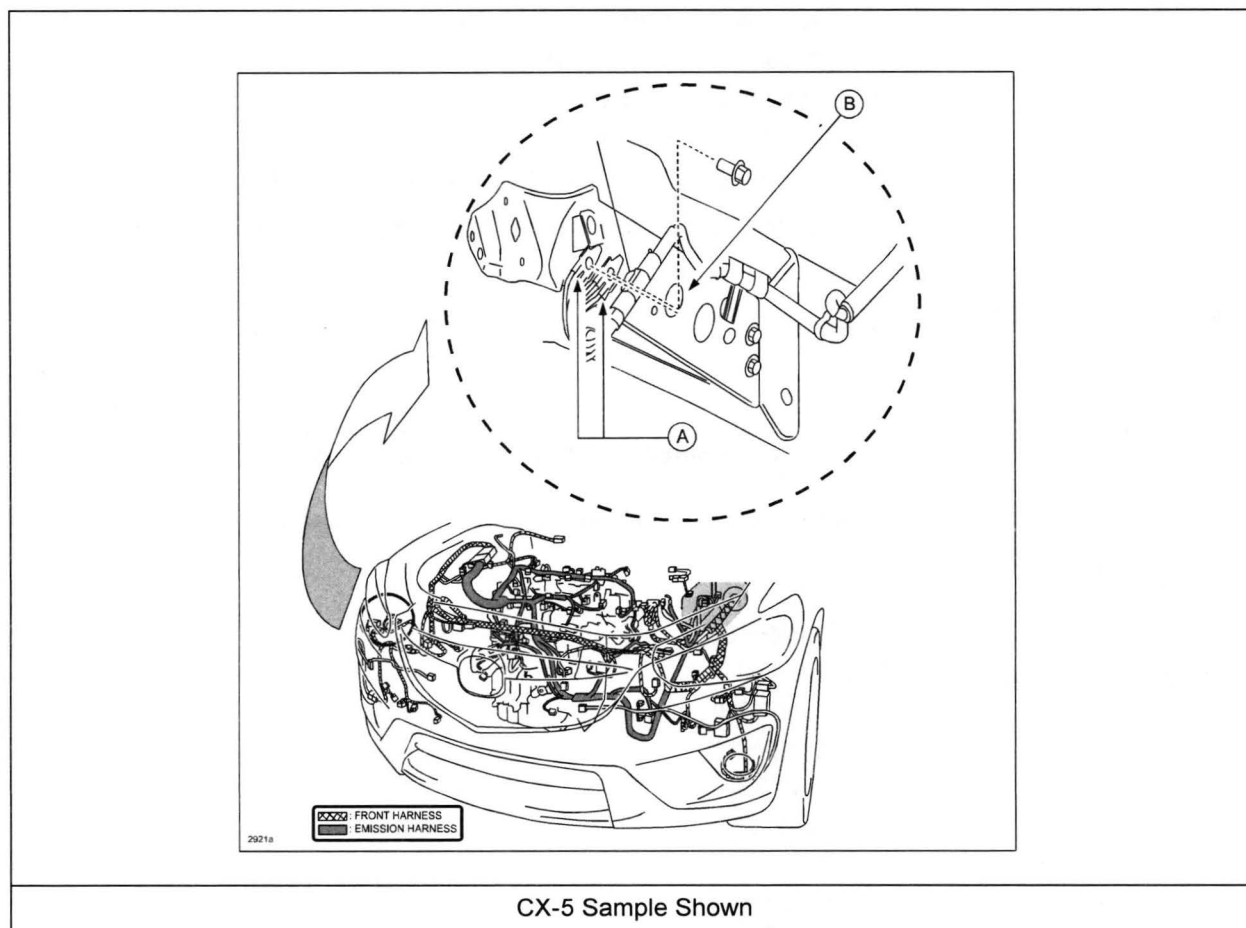
Some customers may experience an electrical malfunction after a vehicle body repair. The newly painted fender stay (B) may be causing a poor front harness (A) ground connection.

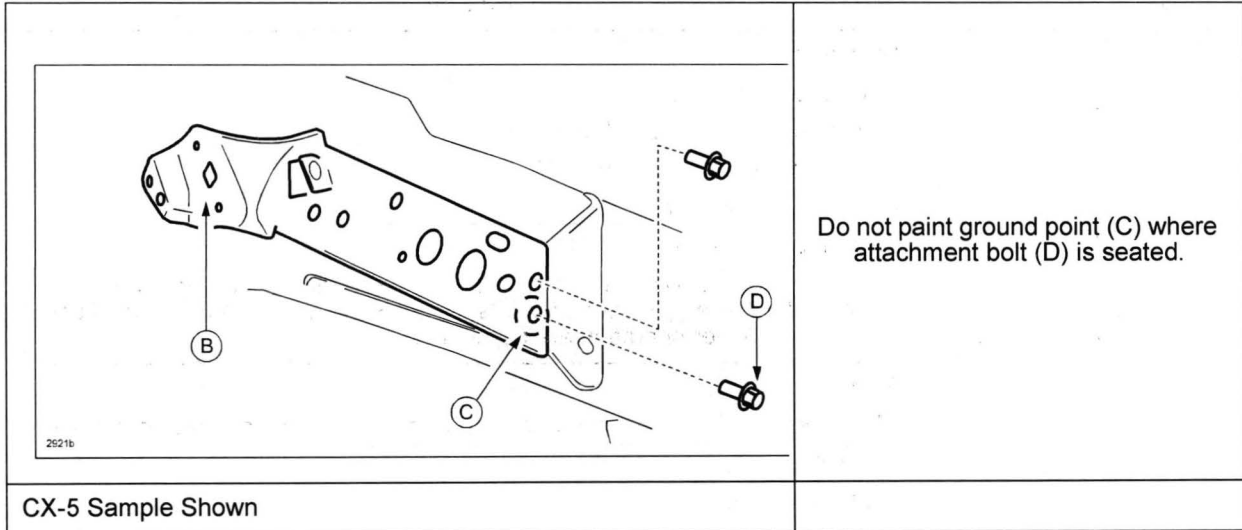
The front fender stay (B) newly painted surface at ground point (C), where attachment bolt (D) is seated, may create a poor front harness ground connection.

Customers concern can be resolved by sanding off paint at ground point (C) where attachment bolt (D) is seated. After installing the bolt (D), apply touch-up paint to the exposed base material area of the front fender stay.

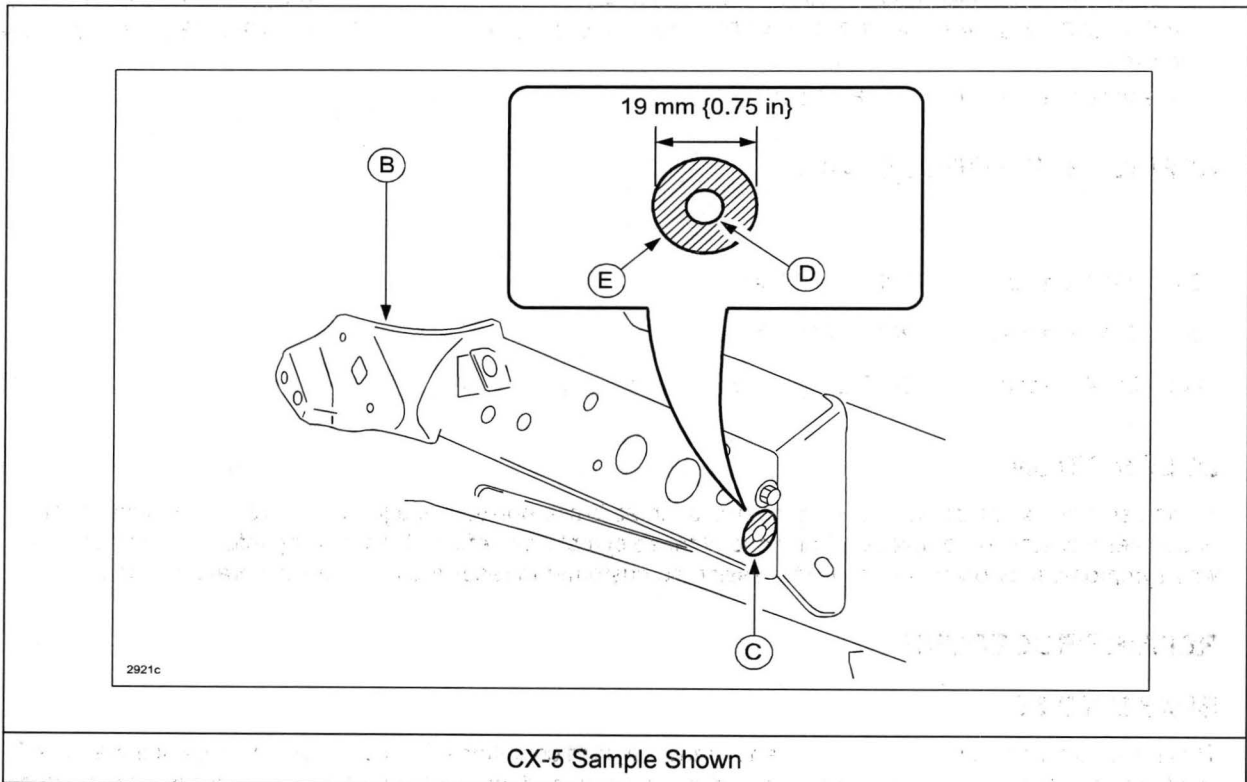
### NEWLY INSTALLED FRONT FENDER STAY NOTE

**CAUTION:** If the bolt (D) contact area (C) is painted when the front fender stay (B) is newly replaced, it could cause a malfunction in the PCM. Before painting a newly replaced part, protect the bolt (D) contact area (C) with masking tape (E) as shown in the figure.

**NOTE:** After installing the bolt (D), apply touch-up paint to the exposed base material area of the front fender stay.
