09-022/14 - MULTI-MODEL - MULTIPLE ELECTRICAL MALFUNCTIONS AFTER BODY REPAIR

Subject: MULTIPLE ELECTRICAL MALFUNCTIONS AFTER BODY REPAIR	Bulletin No: 09-022/14
	Last Issued: 05/30/2014

- 2013-2015 CX-5
- 2014 Mazda3
- 2014-2015 Mazda6

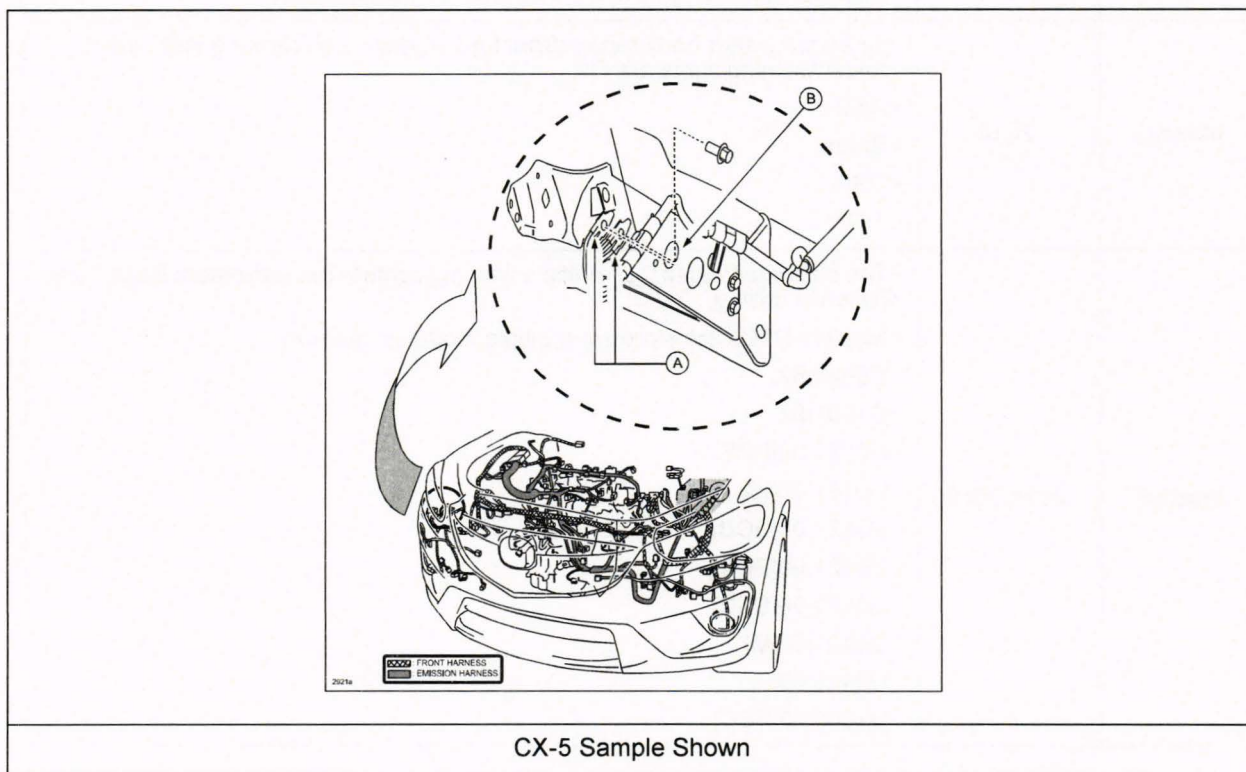
Some customers may experience an electrical malfunction after a vehicle body repair. The newly painted fender stay (B) may be causing a poor front harness (A) ground connection.

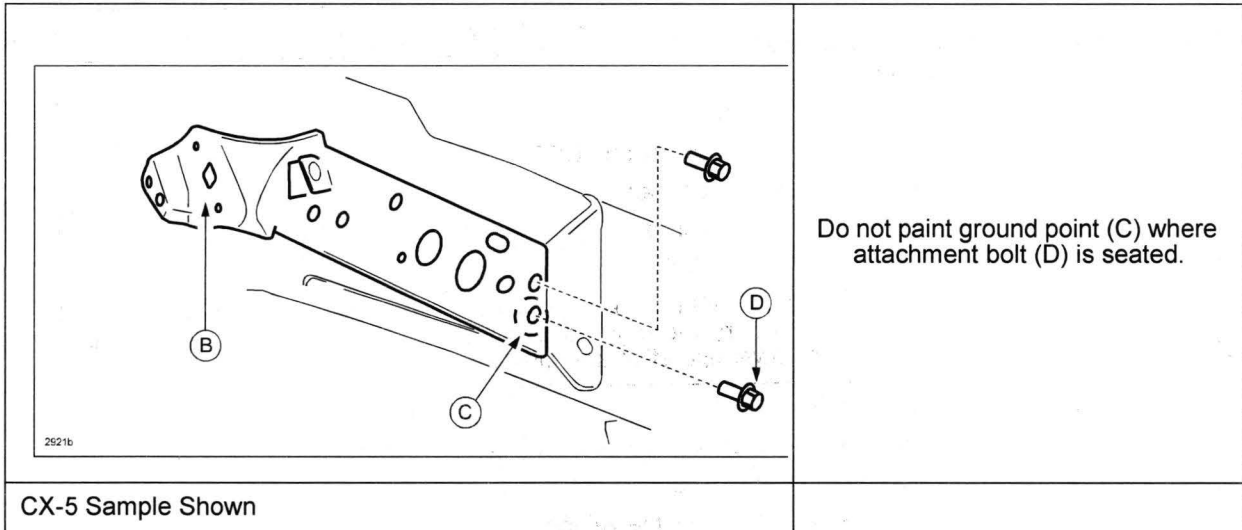
The front fender stay (B) newly painted surface at ground point (C), where attachment bolt (D) is seated, may create a poor front harness ground connection.

Customers concern can be resolved by sanding off paint at ground point (C) where attachment bolt (D) is seated. After installing the bolt (D), apply touch-up paint to the exposed base material area of the front fender stay.

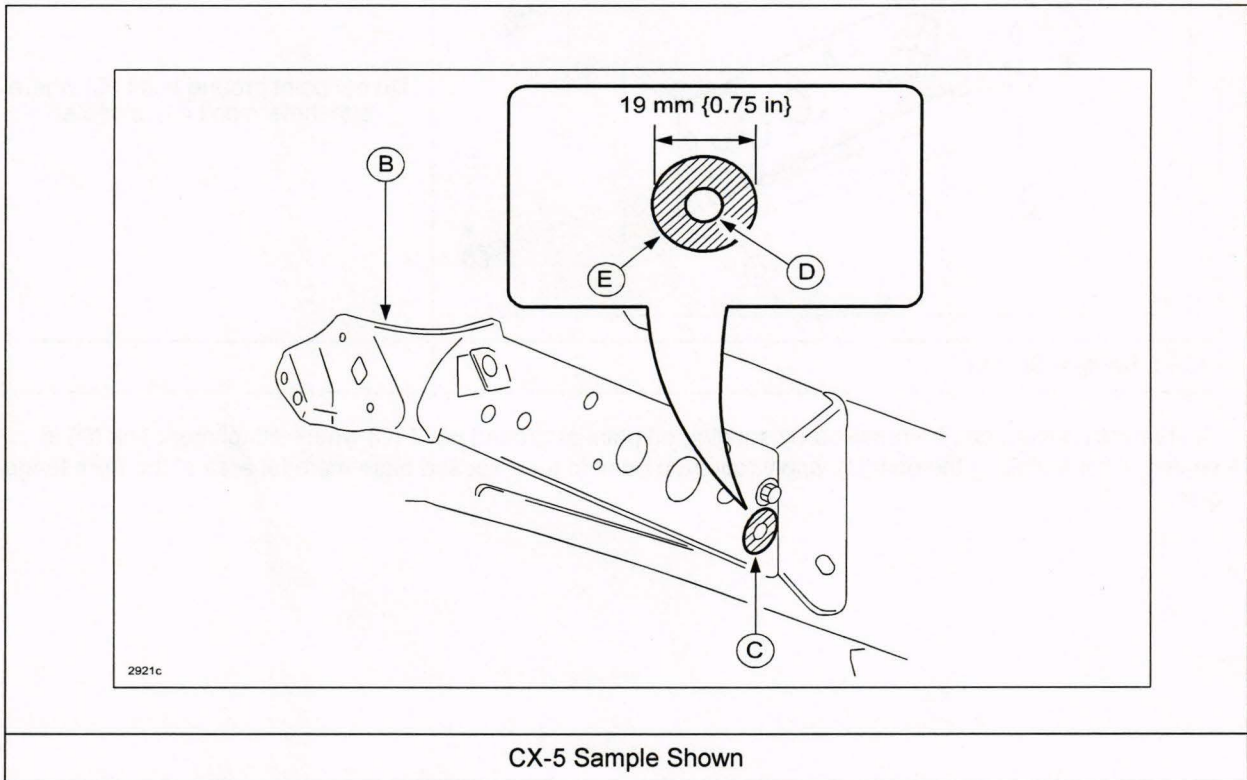
CAUTION: If the bolt (D) contact area (C) is painted when the front fender stay (B) is newly replaced, it could cause a malfunction in the PCM. Before painting a newly replaced part, protect the bolt (D) contact area (C) with masking tape (E) as shown in the figure.

NOTE: After installing the bolt (D), apply touch-up paint to the exposed base material area of the front fender stay.
