09-024/14 – 2014-15 MAZDA3 - SIDE(S) OF REAR SEAT CUSHION IS LIFTING OR LOOSE

Subject: SIDE(S) OF REAR SEAT CUSHION IS LIFTING OR LOOSE	Bulletin No: 09-024/14
	Last Issued: 05/27/2014

2014-15 Mazda3 vehicles

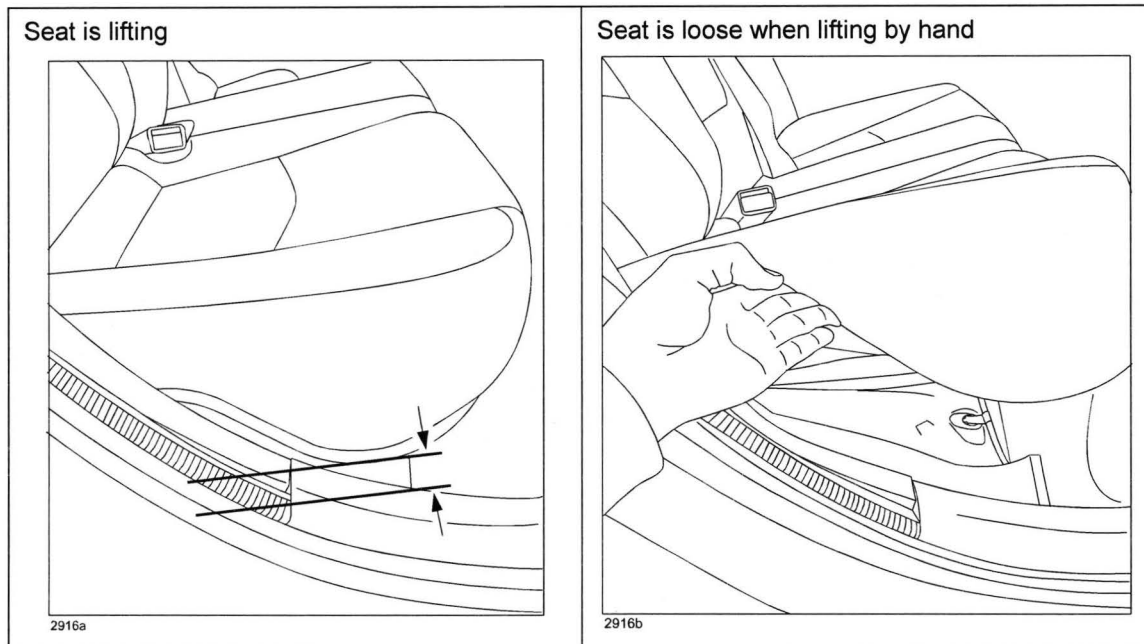
Some customers may complain that the side(s) of the rear seat is lifting or loose when lifted by hand.

This is caused by a product variation of the rear seat cushion. Some cushions may have a larger clearance between the cushion and the floor carpet.

Customers having this concern should have their vehicle repaired using the following repair procedure. When you receive a customer complaint on this concern, fix both sides of the rear seat cushion to the carpet using Velcro tape.
