# Service Bulletin

**CRACKING NOISE FROM WINDSHIELD (SD AND HB) AND/OR REAR WINDOW  
(SD ONLY)**

**Bulletin No:** 09-025/14

2010-2012 Mazda3 (including Mazdaspeed3)

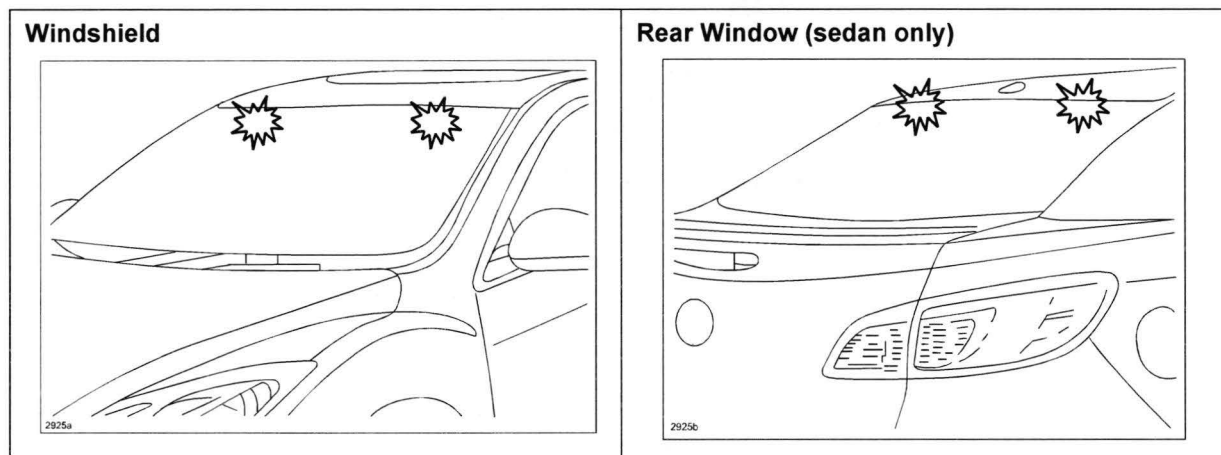
Some vehicles may exhibit a cracking noise originated at the positioning pins near the top corners of the windshield and/or rear window when driving on uneven road surface. This happens when the ambient temperature is approximately 14 °F (-10 °C) or lower and the vehicle cabin has not yet warmed up. The noise is caused by the windshield and/or rear window locating stopper contacting the panel.
