DRIVER-SIDE POWER DOOR MIRROR VIBRATION

Bulletin No: 09-026/14

Last Issued: 06/10/2014

2013-2015 CX-5 vehicles with VINS lower than JM3KE*****465579 (produced before April 1, 2014)

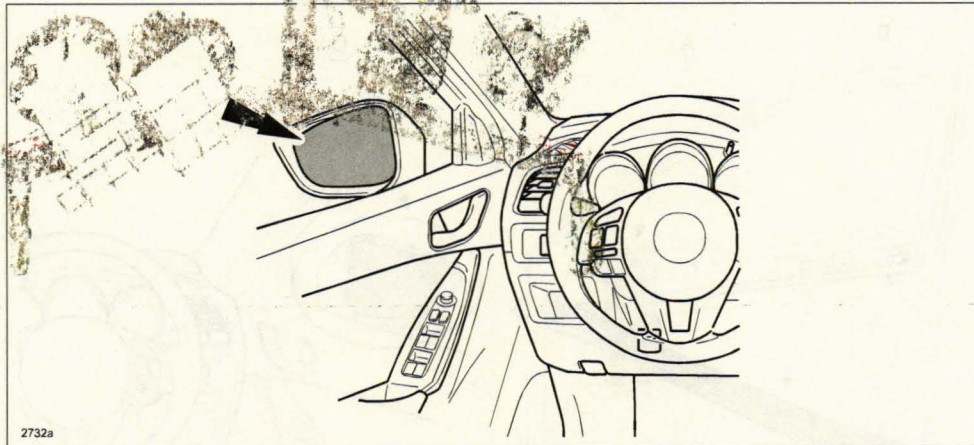
Some vehicles may exhibit a vibration from the driver-side power door mirror glass when the vehicle is driven at high speeds.

This concern may be due to a lack of rigidity of the mirror base so the mirror vibrates when it receives vehicle vibration or wind pressure.

An additional reinforcement has been installed inside the door to increase the door panel strength where the door mirror is mounted. Also, the door mirror shape has been changed. Both of these modifications have been implemented to eliminate mirror glass vibration concerns.

Customers having this concern should have their vehicle repaired using the following repair procedure.
