Service Bulletin

| Subject: HOOD VIBRATION WHILE DRIVING AT HIGHWAY SPEED | Bulletin No: 09-028/14 |

2013-2014 CX-5 vehicles with VINs lower than JM3KE*****387092 (produced before September 1, 2013)

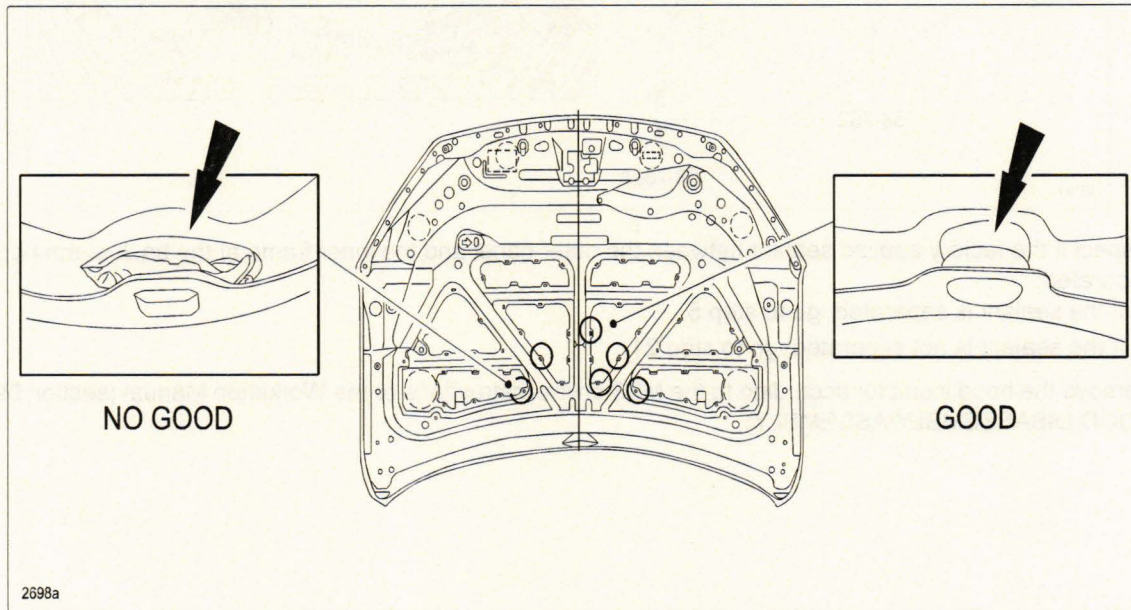
The amount of sealant used to fill in the space between the inner frame and outer panel at the bottom area of the hood is insufficient. If the sealant detaches (as shown below on the left), it may cause the hood to vibrate. The amount of sealant has been increased during vehicle production and the preload force of the cowl grill seal has been increased to eliminate the concern.

The cowl grill seal will be replaced with a modified part, additional dampening material may be applied between the hood's inner frame and outer panel and the hood height may be adjusted to apply additional tension.

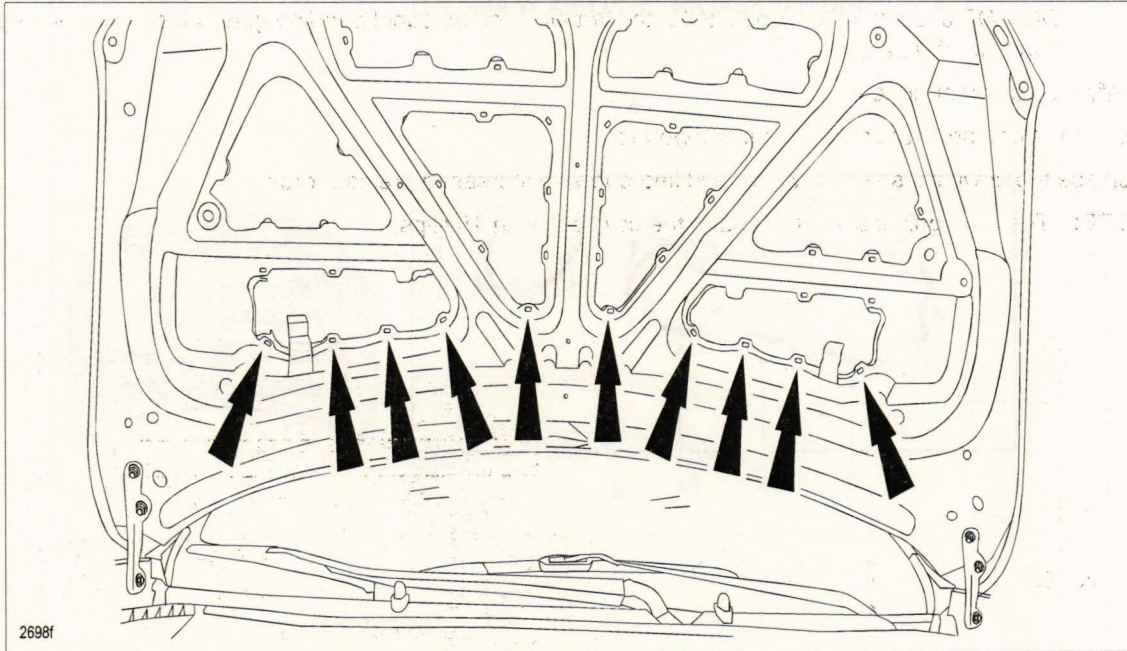
6. Confirm the ten (10) original sealant spots at the bottom area of the hood.

- Additional dampening material will be applied **between** these ten (10) original sealant spots.
- It is not necessary to apply dampening material to other areas of the hood. Even if the original sealant has become detached, it will have no influence on the hood vibration concern.
