09-031/14 - 2013 CX-5 - RUBBER PROTECTOR PARTIALLY COMES OFF SIDE STEP MOLDING CAUSING A POOR APPEARANCE CONCERN

Subject: RUBBER PROTECTOR PARTIALLY COMES OFF SIDE STEP MOLDING CAUSING A POOR APPEARANCE CONCERN	Bulletin No: 09-031/14
	Last Issued: 07/11/2014

2013 CX-5 vehicles with VINs lower than JM3KE*****162631 (produced before November 1, 2012)

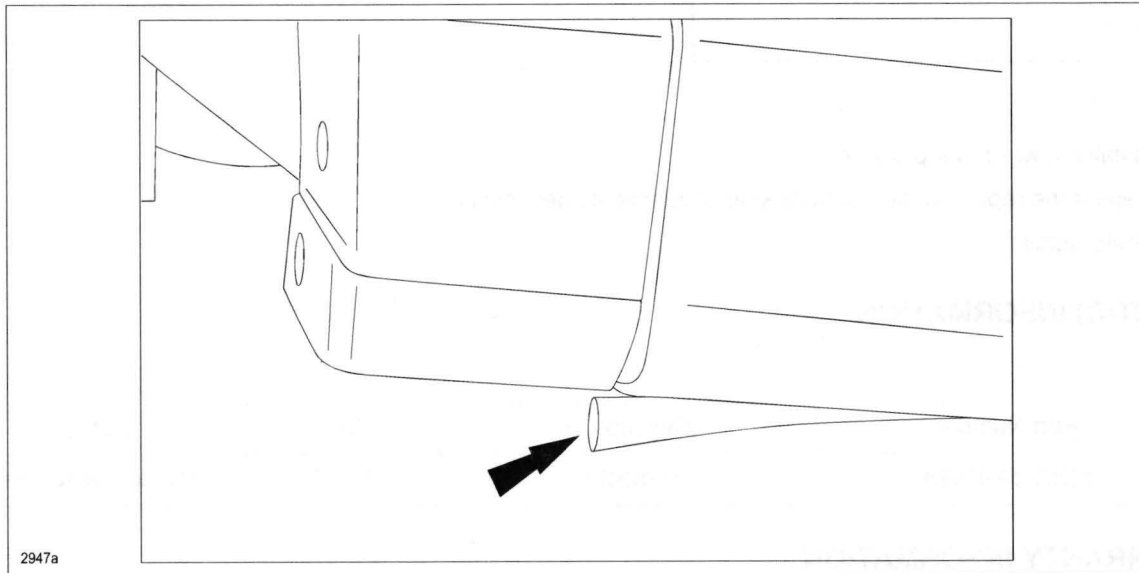
Some customers may complain that the rubber protector comes off the side step molding. The protector hangs down causing a poor appearance concern.

This concern may occur when the vehicle is driven in freezing temperatures. Snow and moisture adhere and freeze onto the rubber protector and when the door is opened, the rubber protector can tear or stretch, coming off the fasteners.

The material of the rubber protector around the fasteners has been changed to increase the holding force to the fasteners.

Customers having this concern should have their vehicle repaired using the following repair procedure.
