# Service Bulletin

CD PLAYER DISPLAY CONCERNS

Bulletin No: 09-032/14

Last Issued: 09/16/2014

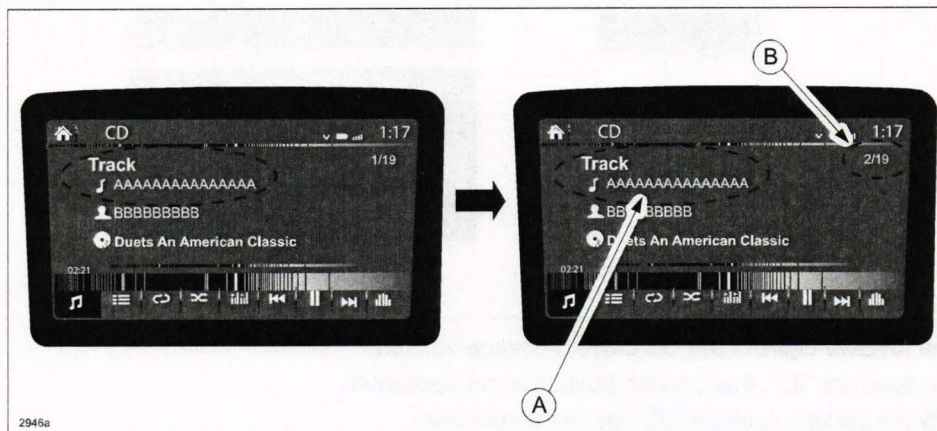
Symptom 1: The song title on the CD display (A) does not change when it goes to the next song. However, the track number (B) changes

This is caused by improper software of the CD player. The software of CD player has now been changed to correct this issue.

Customers having this concern should have their vehicle repaired using the following repair procedure.
