# **Service Bulletin**

SEAT WARMER MALFUNCTION

Bulletin No: 09-033/14

2013-2015 CX-5 vehicles equipped with seat warmers with VINs lower than JM3KE\*\*\*\*\*477565 (produced before May 1, 2014)

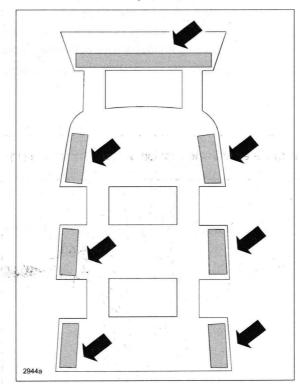
1. Identify the locations of double-sided adhesive tape, which secure the seat warmer to the seat cushion.
