Subject: WIND NOISE FROM DOOR WINDOW EDGE(S) AT 37 MPH OR HIGHER	Bulletin No: 09-036/14
	Last Issued: 08/29/2014

2014-2015 Mazda6 vehicles with VINs lower than JM1 GJ ***** 167429 (produced before January 07, 2014)

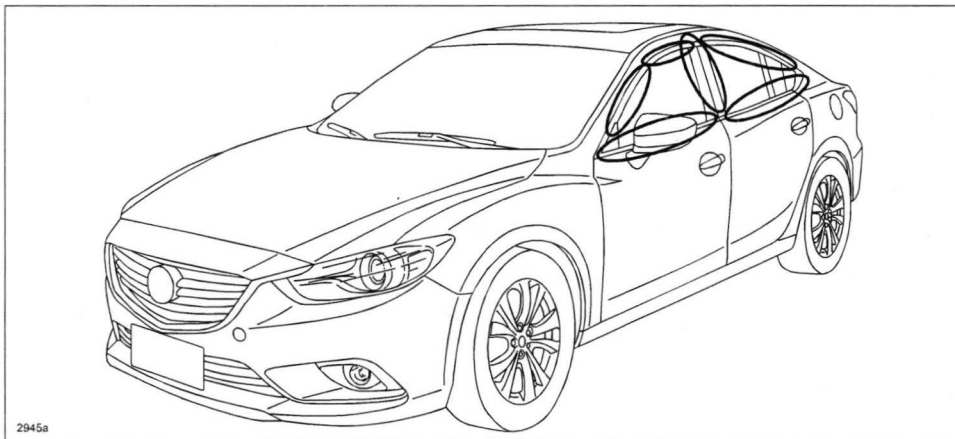
Some vehicles may exhibit a wind noise from the door window edge(s), while driving. The wind noise is most pronounced at approximately 50 mph (81 km/h) on a smooth road. The wind noise may be caused by air passing through gaps between the door edge and the corresponding body panel.

Customers having this concern should have their vehicle repaired using the following repair procedure.
