#### **Technical Service Bulletin**

GROUP	NUMBER				
	CAMPAIGN	14-01-036-1				
5.	DATE	MODEL(S)				
	OCTOBER 2014	ELANTRA SEDAN				
		(UD)

SUBJECT: OVERHEAD CONSOLE SUNGLASS HOLDER LATCH REPLACEMENT PROCEDURE, (SERVICE CAMPAIGN TT9)

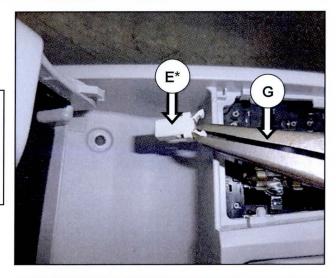
Before installation, compare the orientation of the holder latch (E\*) with the picture on the right. The slotted side should be facing away from your view.

7. Insert the new holder latch (E\*) with needle nose pliers (G) in the orientation shown.
