Technical Service Bulletin

GROUP	NUMBER
CAMPAIGN	14-01-041
DATE	MODEL(S)
OCTOBER 2014	SANTA FE SPORT (AN)

SUBJECT: STEERING COLUMN U-JOINT NOISE FROM NOISE ISOLATION PAD (SERVICE CAMPAIGN TU3)

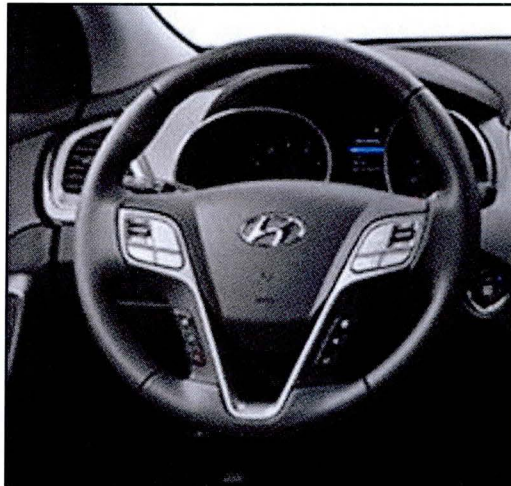
Description: This bulletin describes the procedure to inspect and repair certain Santa Fe Sport (AN) vehicles for a rubbing or popping noise. The noise isolation pad may be positioned in such a way that it contacts the steering column U-joint when turning the steering wheel.

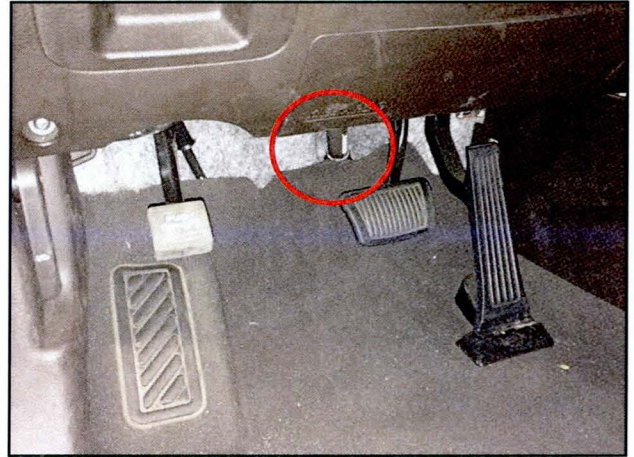
1. Locate the steering column shaft and U-joint connection to the steering rack at the firewall in the driver's foot-well area.

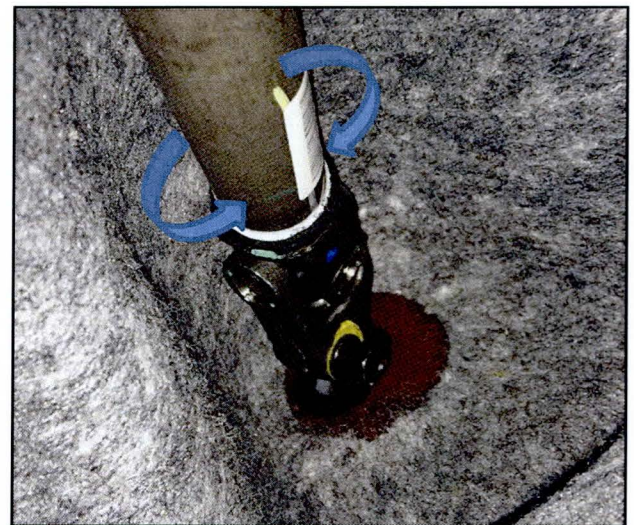
2. Turn the steering wheel left and right full-lock in each direction repeatedly. While doing so, listen and look at the area to identify any noise and/or rubbing condition between the U-joint and the noise isolation pad.

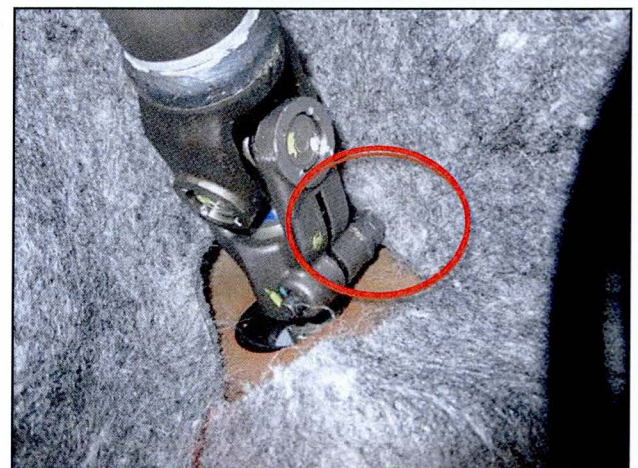
3. Using a light if needed, locate the area of contact.

- Using a utility blade (or other desired trimming tool), remove 5~10mm of noise isolation pad material from the area of contact to eliminate the noise.
