HYUNDAI NEW THINKING. NEW POSSIBILITIES. Technical Service Bulletin	GROUP CAMPAIGN	NUMBER 14-01-046
	DATE NOVEMBER 2014	MODEL(S) GENESIS SEDAN (DH) SONATA (LF)
SUBJECT:	NAVIGATION OPERATING SYSTEM SOFTWARE UPDATE (SERVICE CAMPAIGN TU7)

Description: This bulletin provides a service procedure to update the navigation software. The update addresses the issue with intermittent no audio after using the Bluetooth hands free system. After hanging up a call, intermittently the audio sound does not return.

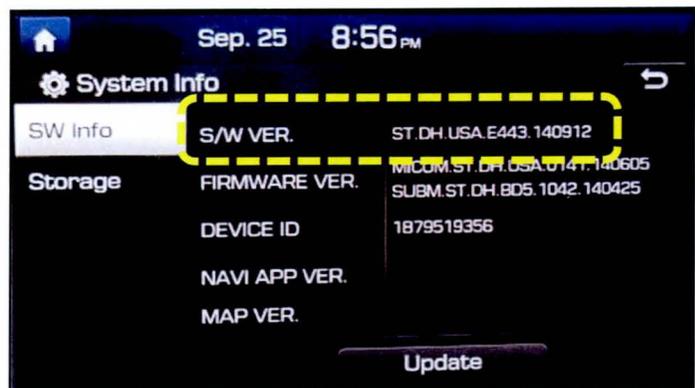
If the version is as follows, no further procedure is required.

S/W Version
ST.DH.U.S.A.E443.140912

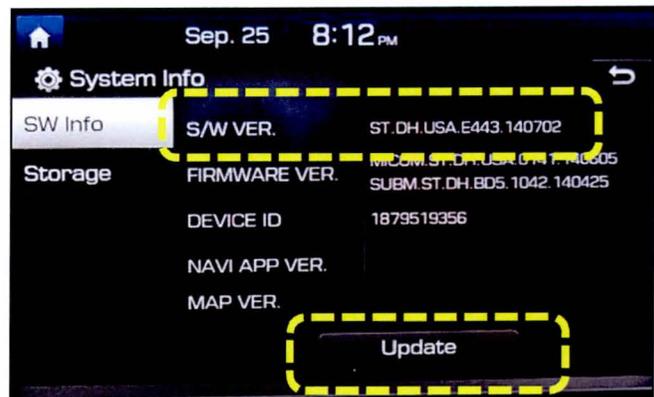
S/W Version
ST.DH.U.S.A.E443.140702

If the version is as follows, press the **Update** button to initiate S/W update.

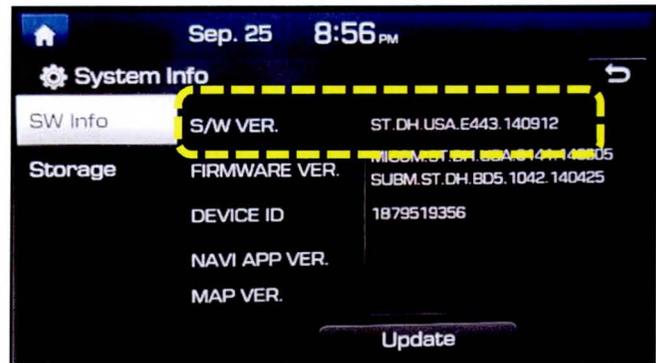
S/W Version
ST.DH.USA.E443.140912

11. After system restart, check the version again following pages 4 to 5. Confirm the version is as shown below.

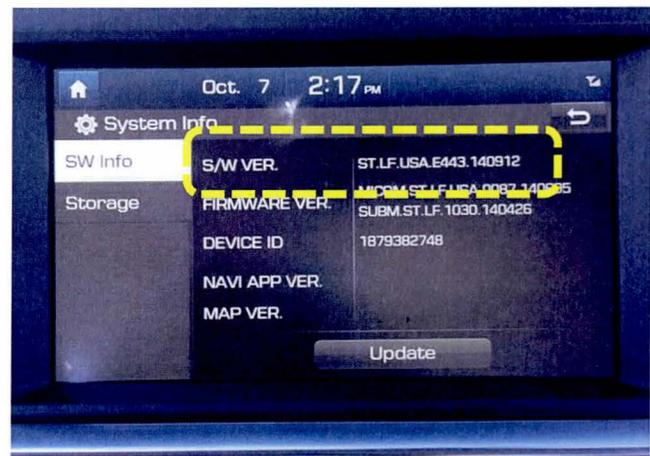
If the version is as follows, no further procedure is required.

S/W Version
ST.LF.USA.E443.140912

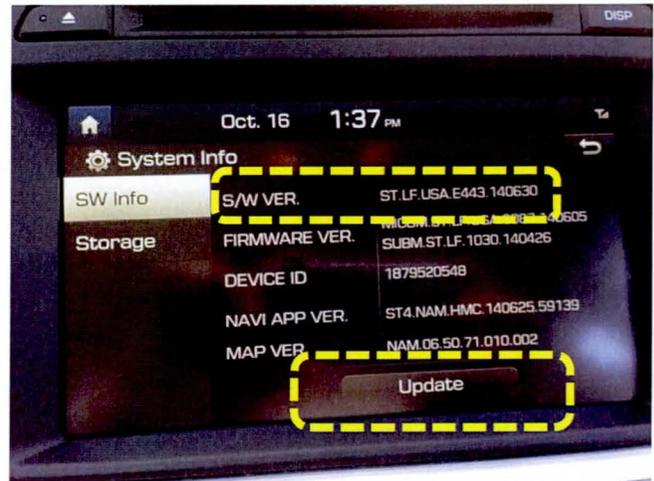
S/W Version
ST.LF.USA.E443.140630

If the version is as follows, press the **Update** button to initiate S/W update.

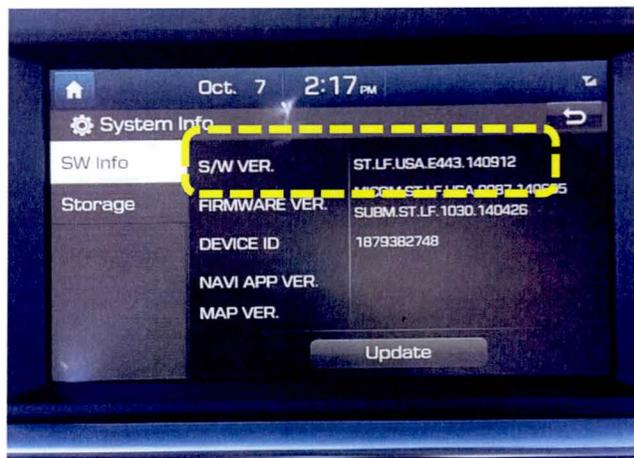
S/W Version
ST.LF.USA.E443.140912

11. After system restart, check the version again following pages 9 to 10. Confirm the version is as shown below.
