| HYUNDAI NEW THINKING. NEW POSSIBILITIES. Technical Service Bulletin | GROUP CAMPAIGN | NUMBER 14-01-039-1 |
| | DATE OCTOBER 2014 | MODEL(S) GENESIS SEDAN (DH) SONATA (LF) |
| SUBJECT: | NAVIGATION OPERATING SYSTEM SOFTWARE UPDATE (SERVICE CAMPAIGN TU2) | |

This TSB supersedes TSB# 14-01-039 to add 2015 Sonata (LF)

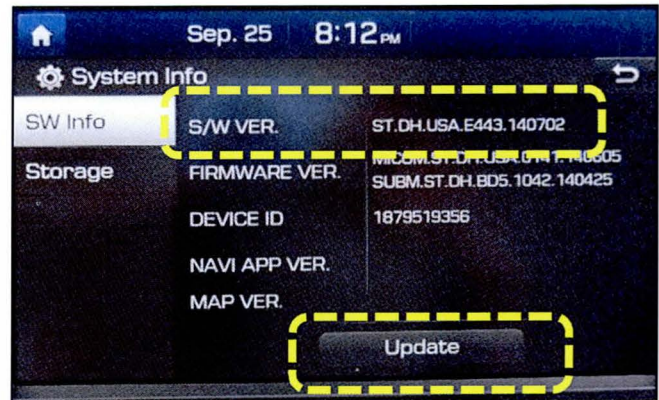
If the version is as follows, press the **Update** button to initiate S/W update.

| ST.DH.U.S.A.E443.140702 |

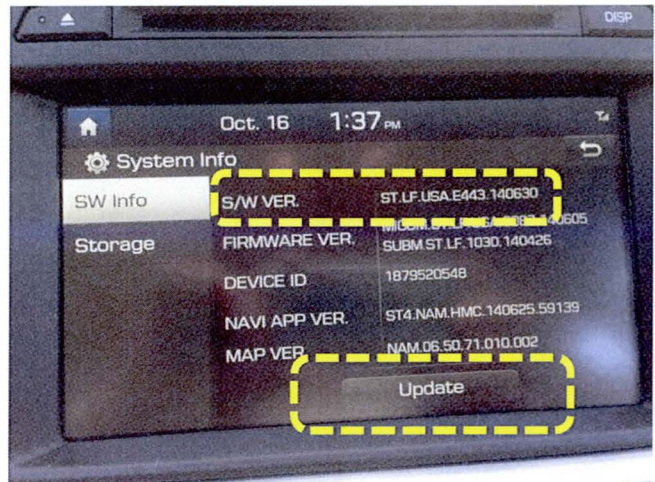
If the version is as follows, press the **Update** button to initiate S/W update.

| ST.LF.USA.E443.140630 |
