# EV System Software Update

YEAR(S)	MODEL(S)	ADDITIONAL INFORMATION
2012 – 2014	RAV4 EV

The information contained in this bulletin supersedes SB No. T-SB-0050-13.

The RAV4 EV Power Management Control ECU and EV Gateway Control ECU software has been updated to improve charging performance. To ensure the best ownership experience, it is important to confirm the software is the most current version available. Use the following procedure to reprogram the RAV4 EV Power Management Control ECU and EV Gateway Control ECU.

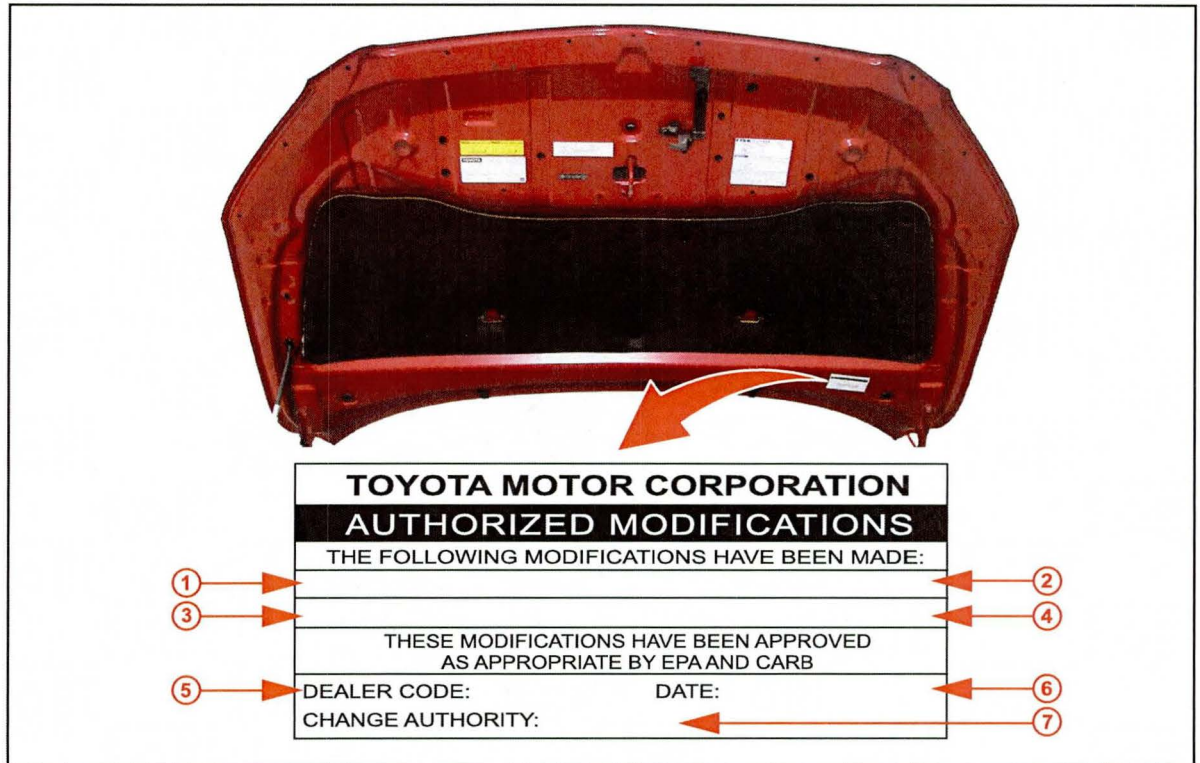
Figure 1. Location of Authorized Modifications Label on 2012 – 2014 RAV4 EV

1. Check for the Authorized Modifications Label affixed to the vehicle in the location shown in Figure 1. Confirm if the ECU calibrations have been updated. If the calibration IDs listed are NOT the latest ECU calibrations — go to step 2.

1	Replacement Power Management Control ECU Part Number (i.e., 89690-42015)
2	Replacement EV Gateway Control ECU Part Number (i.e., 89881-0R011)
3	New Calibration ID of Power Management Control ECU (i.e., 896B34201500)
4	New Calibration ID of EV Gateway Control ECU (i.e., 1.3.83)

5	Dealer Code
6	Date Completed
7	This SB Number

4. Install the Authorized Modifications Label.
  - A. Using a permanent marker, enter the following information on the label:
    - ECU part number(s) [Refer to the **Parts Information** section for the **NEW PART NUMBER**]
    - Calibration ID(s) [Refer to the **Calibration Information** section for the **NEW CALIBRATION ID**]
    - Dealer Code
    - Repair Date
    - Change Authority [**This SB number**]
  - B. Affix the Authorized Modifications Label to the vehicle at the location shown in Figure 1. The Authorized Modifications Label is available through the MDC, P/N 00451-00001-LBL.
5. Test drive the vehicle to confirm proper vehicle operation.
