Shudder on Deceleration After a Cold Soak

Service Category Drivetrain

Section Automatic Transmission/Transaxle

YEAR(S)	MODEL(S)	ADDITIONAL INFORMATION
2012 – 2014	Tacoma	Transmission(s): 4AT

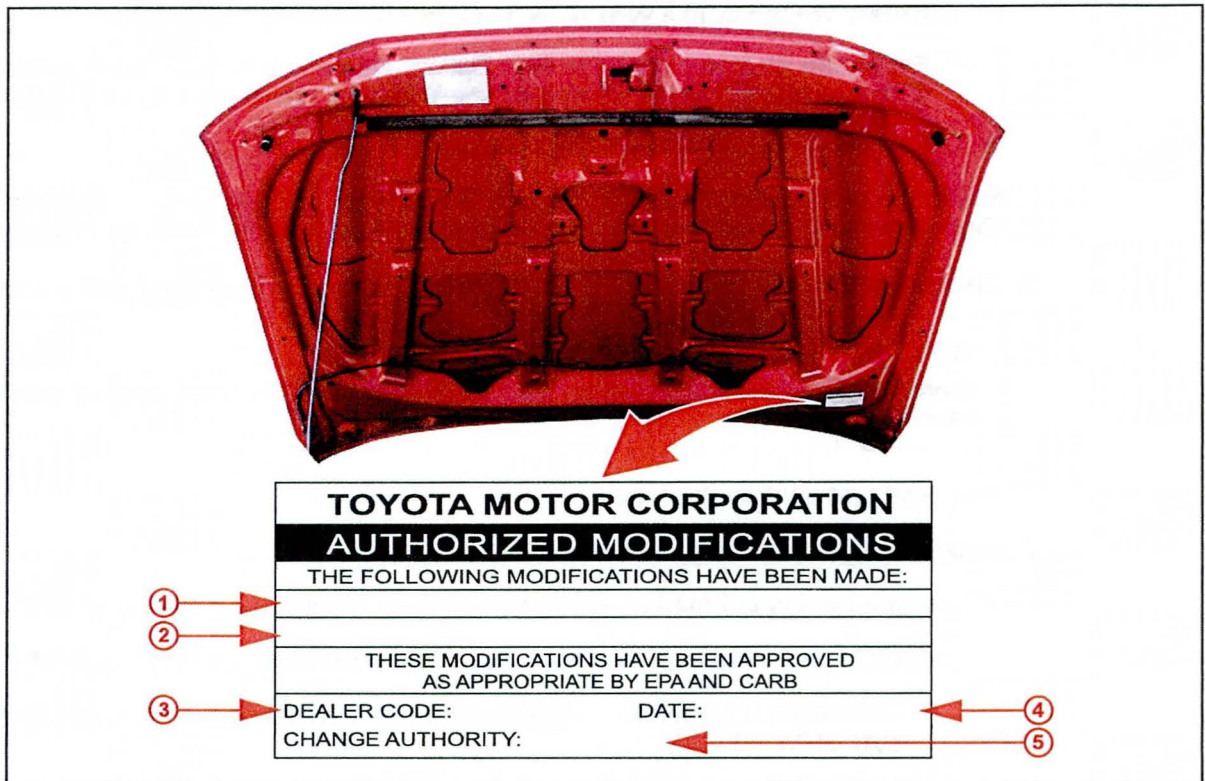
Figure 1. Location of Authorized Modifications Label on 2012 - 2014 Tacoma

3. Check for the Authorized Modifications Label affixed to the vehicle in the location shown in Figure 1. Confirm if the ECM (PCM) calibration has been updated. If the calibration ID listed is NOT the latest ECM (PCM) calibration — go to step 4.

6. Test drive and confirm the repair.
7. Install the Authorized Modifications Label.
 - A. Using a permanent marker, enter the following information on the label:
 - ECM part number [*Refer to the **Parts Information** section for the **NEW PART NUMBER***]
 - Calibration ID(s) [*Refer to the **Calibration Information** section for the **NEW CALIBRATION ID***]
 - Dealer Code
 - Repair Date
 - Change Authority [***This bulletin number***]
 - B. Affix the Authorized Modifications Label to the vehicle at the location shown in Figure 1. The Authorized Modifications Label is available through the MDC, P/N 00451-00001-LBL.
