Shudder on Deceleration After a Cold Soak

YEAR(S)	MODEL(S)	ADDITIONAL INFORMATION
2012 – 2014	Tacoma	Transmission(s): 4AT

Some 2012 – 2014 model year Tacoma vehicles equipped with the A340 automatic transmission may exhibit a shudder condition on deceleration at approximately 20 mph after the vehicle has cold soaked. The Engine Control Module/ECM (SAE term: Powertrain Control Module/PCM) logic has been modified to reduce the possibility of this condition occurring. Use the following procedure to address this condition.

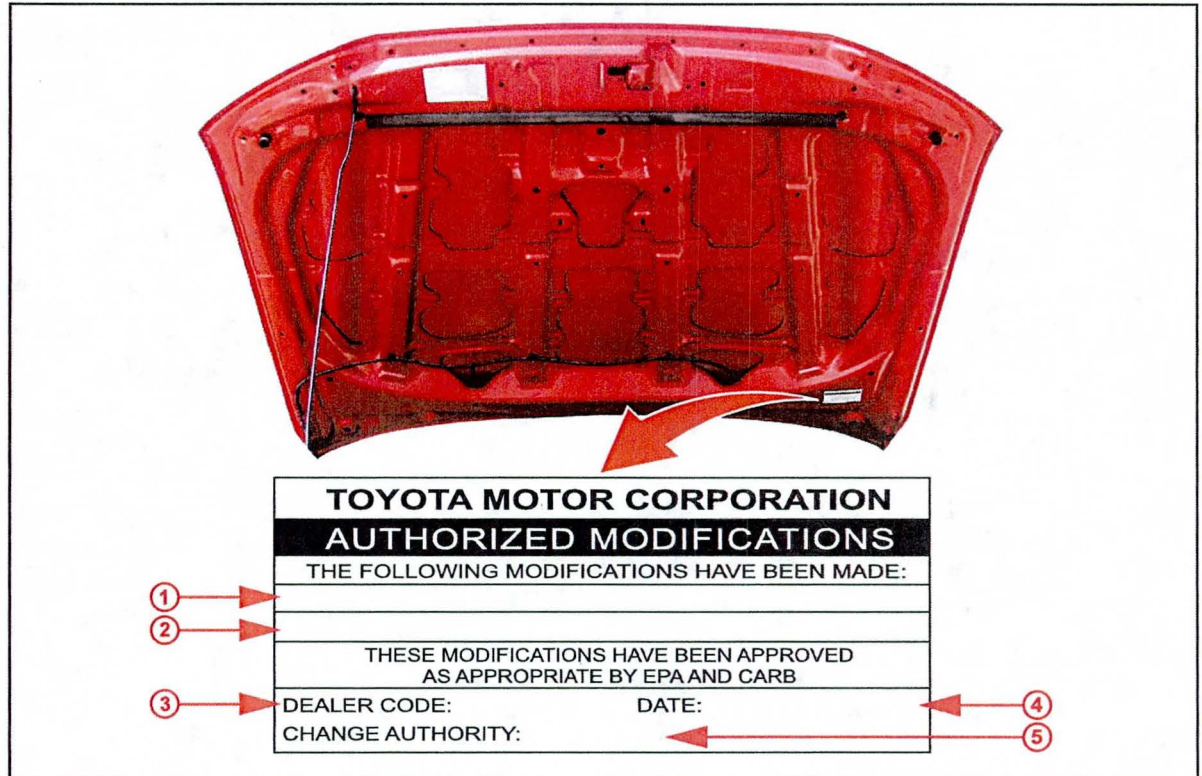
Figure 1. Location of Authorized Modifications Label on 2012 - 2014 Tacoma

3. Check for the Authorized Modifications Label affixed to the vehicle in the location shown in Figure 1. Confirm if the ECM (PCM) calibration has been updated. If the calibration ID listed is NOT the latest ECM (PCM) calibration — go to step 4.

6. Test drive and confirm the repair.
7. Install the Authorized Modifications Label.
 - A. Using a permanent marker, enter the following information on the label:
 - ECM part number [Refer to the **Parts Information** section for the **NEW PART NUMBER**]
 - Calibration ID(s) [Refer to the **Calibration Information** section for the **NEW CALIBRATION ID**]
 - Dealer Code
 - Repair Date
 - Change Authority [**This bulletin number**]
 - B. Affix the Authorized Modifications Label to the vehicle at the location shown in Figure 1. The Authorized Modifications Label is available through the MDC, P/N 00451-00001-LBL.
