T-SB-0042-14

# Rear Suspension Toe Adjustment Out of Specification after SR CSJ

YEAR(S)	MODEL(S)	ADDITIONAL INFORMATION	
2006 – 2011	RAV4

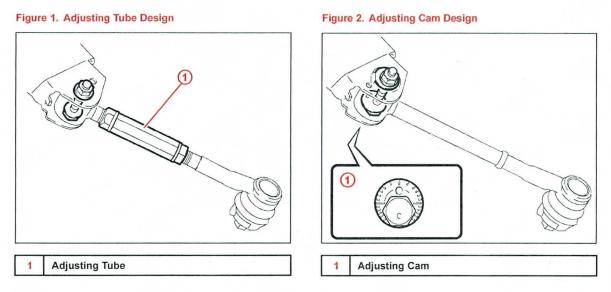
- If the design is the Adjusting Tube style (Figure 1), proceed with this bulletin. Go to step 2.
- If the design is the Adjusting Cam style (Figure 2), this bulletin does NOT apply. Continue diagnosis using the applicable Repair Manual.
- 2. Check for completion of Safety Recall CSJ: *"2006 – 2011 RAV4; Rear Lower Suspension Arm No. 1."*
