Seat Heater Element Twisted/Bunched

Service Category Vehicle Interior

Section Seat

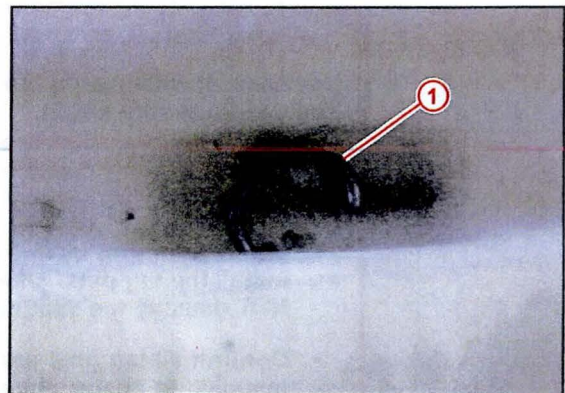
Figure 1.

To prevent seat damage and potential injury, ensure all the clipped Hog Rings are removed.

1 Remove Clipped Hog Rings

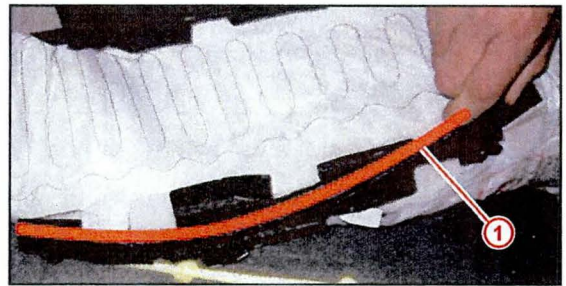
Figure 2.

Ensure all 22 tabs of seat heater element are attached to seat cover (NEW level parts have an additional two tabs).

1 Do NOT Bend Hog Ring Anchor Rod
