Best practices when performing TSIB L-SB-0008-12

Market
USA

2010-2014 LS460 FSPORT

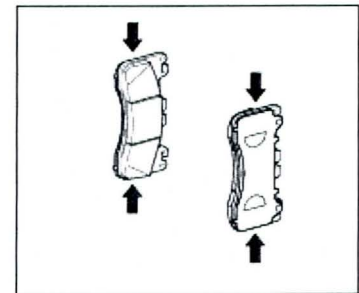
Application point of grease

1. Do NOT polish and/or grind the brake disc.
Also, do not replace the brake disc unless the disc thickness is less than 33.0 mm (1.30 in.).
2. Grease is included with the front disc brake pad kit. Apply a light coat of disc brake grease to the edges of the brake pads as shown in the illustration. Additionally, ensure there is no oil and/or grease on the friction surfaces of the pads and the disc.
3. Make sure the single slotted pad is installed on the inside location of the brake disc.
4. Perform all repairs following the TSIB L-SB-0008-12 or repair manual. Disregard the replacement instructions that are included with the front disc brake pad kit by the brake pad kit supplier.
