ech Tip T-TT-0287-14

2014 Tundra Vehicles With Steel Bumper Ultrasonic Parking Sensor Installation

Park Assist False Activation on Vehicle with Steel Bumpers

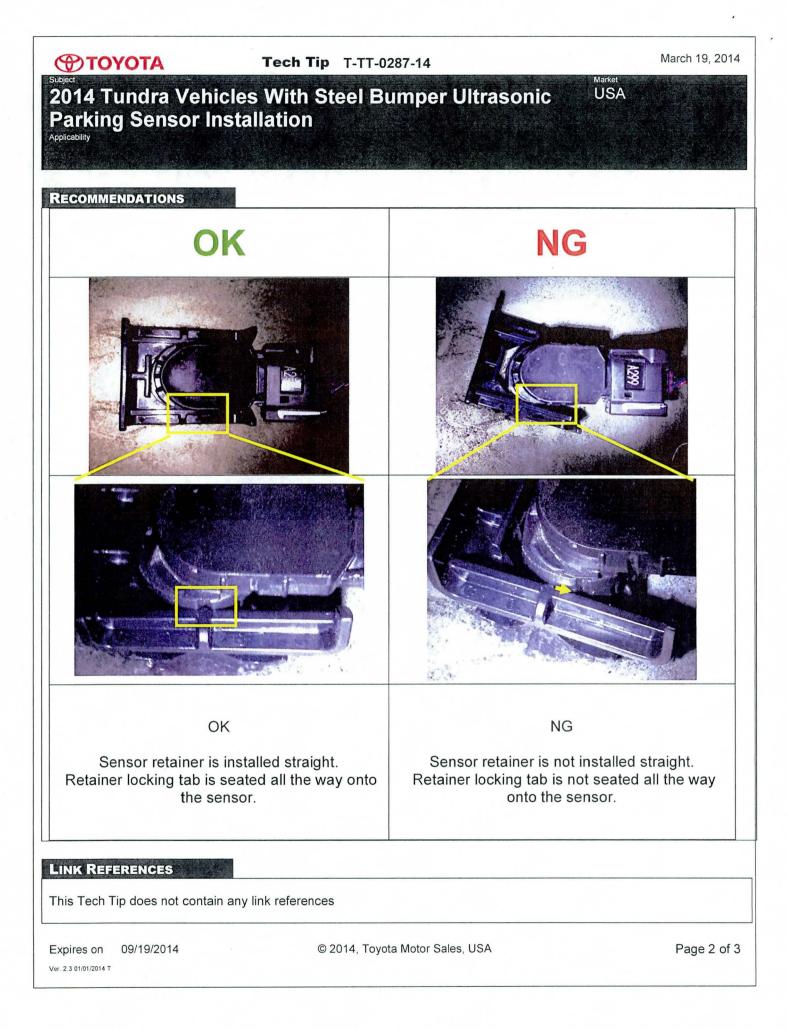
• For proper sonar sensor operation the sensor retainer must be installed straight and fully seated onto the sensor (please see examples on following page)

- Do not reuse the ultrasonic sensor retainer on vehicles that have a false activation concern
- When reinstalling an ultrasonic sensor into the steel bumper, pay special attention to step 2 sub section (a) in the repair manual document for sensor installation.
- 2. INSTALL NO. 2 ULTRASONIC SENSOR RETAINER (for Steel Type Bumper)

(a) Install the No. 2 ultrasonic sensor retainer as shown in the illustration.
