Service Bulletin

DASHBOARD UPPER PANEL STICKY SURFACE AND/OR WARPING

Bulletin No: 09-038/14

2010-2013 Mazda3 vehicles with VINs between:

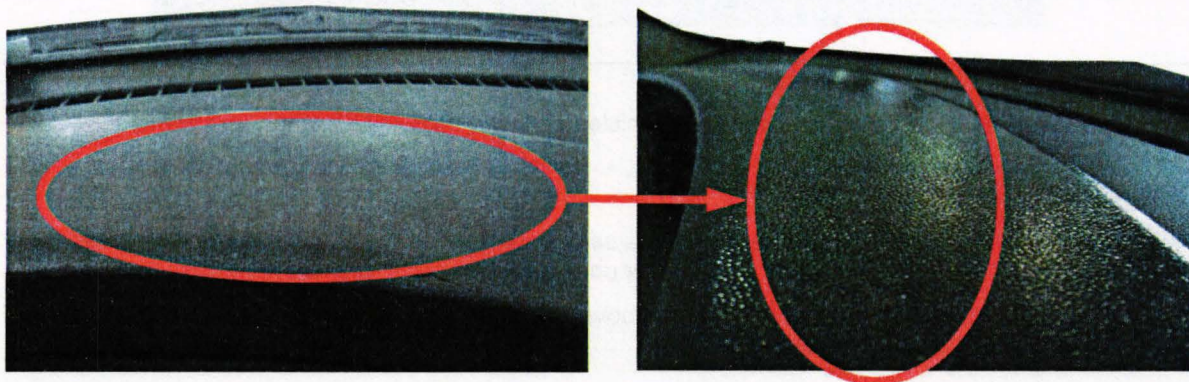
Dashboard Upper Panel Sticky Surface

- a. The dashboard upper panel is sticky.

Customers having this concern should have their vehicle repaired using the following repair procedure.

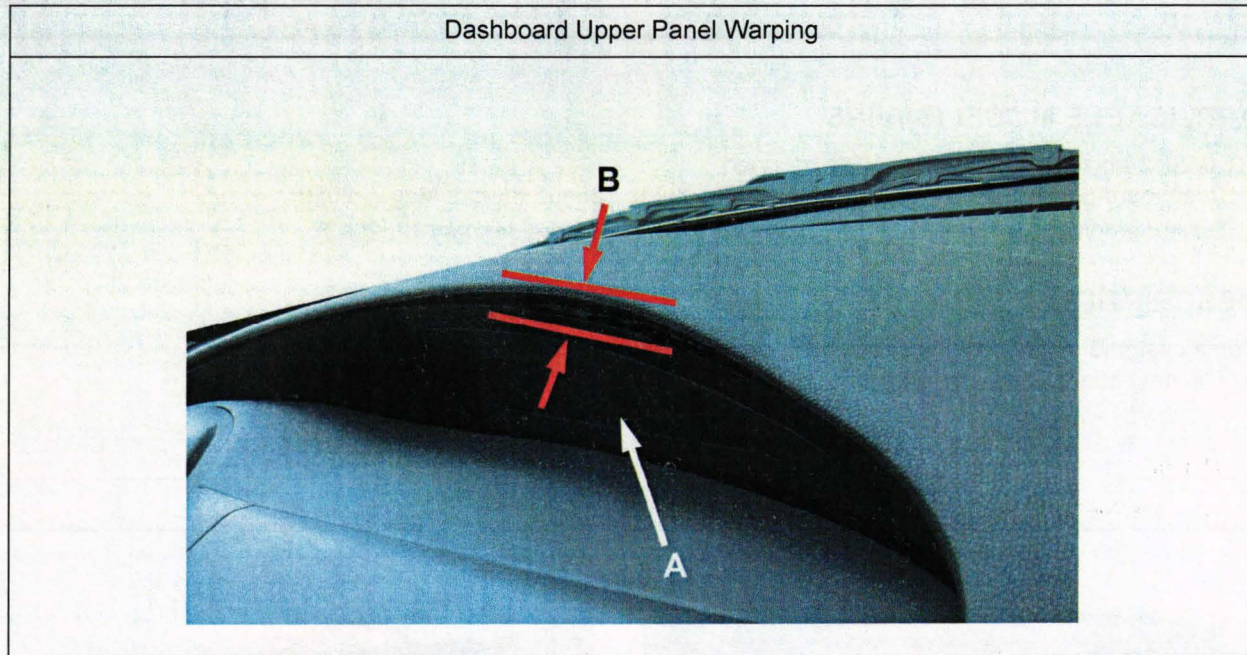
- b. The dashboard upper panel just above the information display (A) is warping, generating a gap (B).
