Subject: BUZZING NOISE FROM DRIVER'S SIDE OF DASHBOARD	Bulletin No: 09-040/14
	Last Issued: 09/18/2014

2014 Mazda3 vehicles with VINs lower than JM1BM*****194915 (produced before March 19, 2014)

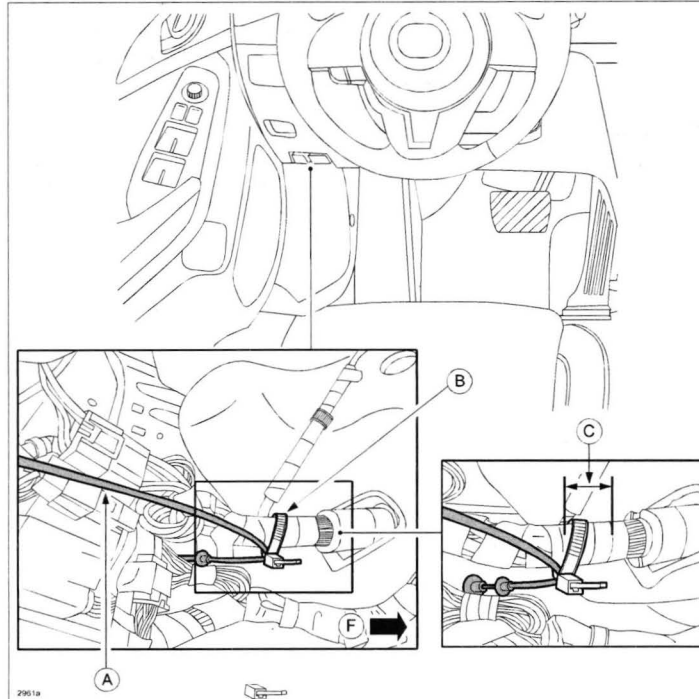
Some vehicles may exhibit a buzzing noise from the driver's side dashboard when driving on a rough road. This noise may be caused by the hood release inner wire contacting the outer cable. To correct the problem, the configuration of the hood release cable has been changed.

1. Verify customer concern.
2. Change the installation layout (bending angle) of the hood release cable in order to avoid the inner wire shaking in the outer cable when driving on rough roads.
 - a. Re-position the hood release cable to the harness (F=front of vehicle).
 - b. Secure the cable (A) to the harness with a zip tie (B) within the area indicated by the arrow (C).
