SERVICE BULLETIN RELEASE - 09/24/2014

09-041/14 - 2014-2015 MAZDA6 - REAR DOOR WEATHERSTRIP OUT OF POSITION

Subject: REAR DOOR WEATHERSTRIP OUT OF POSITION	Bulletin No: 09-041/14
	Last Issued: 09/24/2014

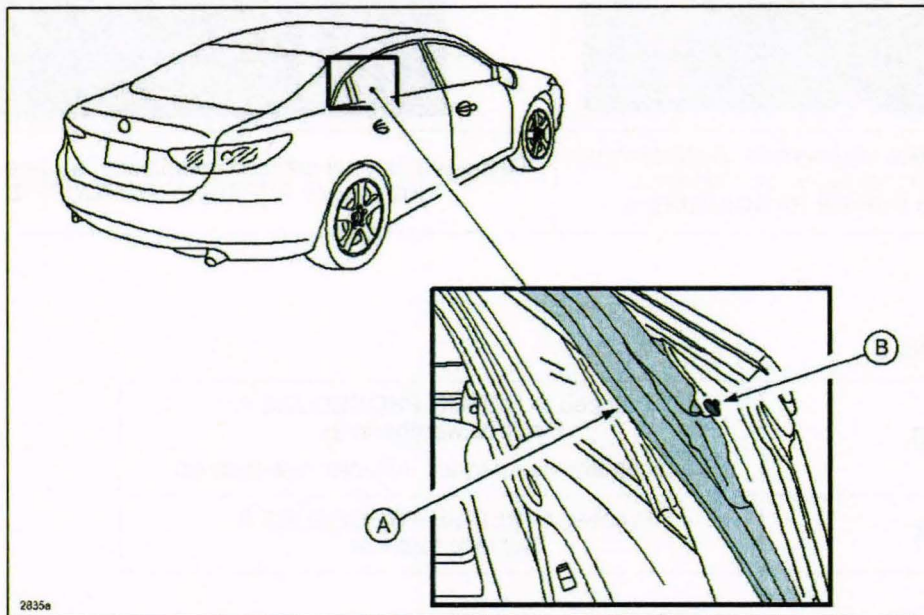
Some customers may have a concern with the top edge of the rear door weatherstrip (A) detached (coming off / falling off) from fastener (B).

Customers having this concern should have their vehicle repaired using the following repair procedure.

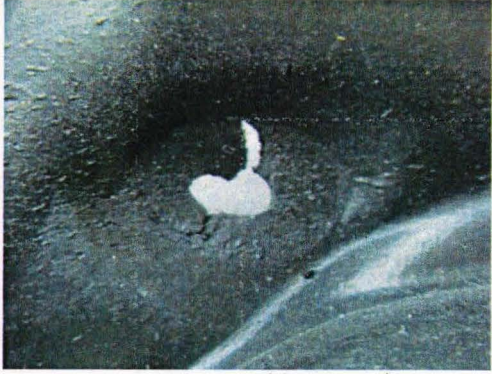
- If cracked as shown "NG", proceed to REPAIR PROCEDURE A.
- If damaged, but not cracked completely as shown "OK", proceed to REPAIR PROCEDURE B.

<p>Cracked, replace weatherstrip. Replacement weatherstrip includes new fastener. Proceed to REPAIR PROCEDURE A.</p>	<p>Damaged, but not cracked completely, replace fastener. Proceed to REPAIR PROCEDURE B.</p>

NG	Proceed to REPAIR PROCEDURE A. Replace weatherstrip. Replacement weatherstrip includes new fastener.
OK	Proceed to REPAIR PROCEDURE B. Replace fastener.
