09-042/14 – 2014 -2015 MAZDA3 - WHITE FELT VISIBLE FROM FRONT DOOR TRIM JOINT CAUSING POOR APPEARANCE

Subject: WHITE FELT VISIBLE FROM FRONT DOOR TRIM JOINT CAUSING POOR APPEARANCE	Bulletin No: 09-042/14
	Last Issued: 09/26/2014

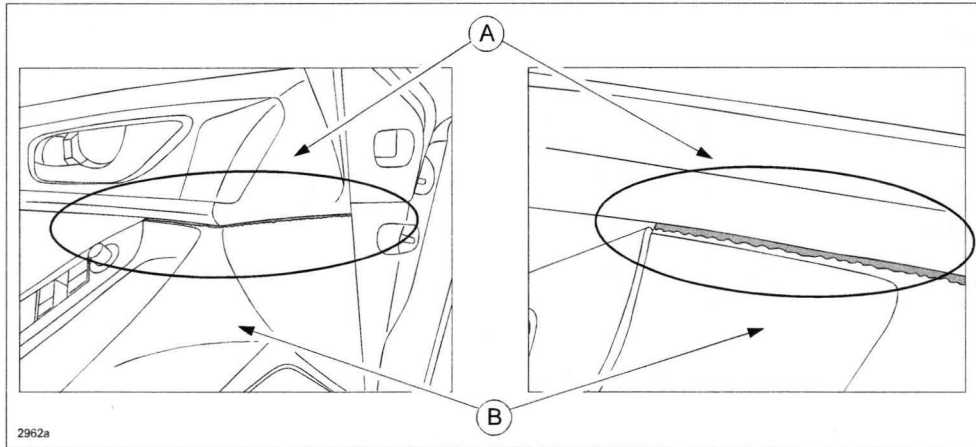
Some vehicles may exhibit a white felt (used for noise insulation) visible through the gap between the upper (A) and lower (B) front door trim, causing a poor appearance.

The cause of this is that the color of the felt and the glue is not appropriate and highly visible. To correct the problem, the color of the felt and the glue has been changed to one that resembles the door trim. The production control and the inspection have also been improved to eliminate the protruding felt.

1. Verify customer concern.
2. Replace the concerned front door trim with a modified one according to the instructions on MS3 online or the Workshop Manual (section 09-17 FRONT DOOR TRIM REMOVAL/INSTALLATION).
3. Verify repair.
