Service Bulletin

| Subject: REAR CONSOLE LID IS LOOSE | Bulletin No: 09-045/14 |

2014 Mazda6 vehicles with VINs lower than JM1 GJ ***** 186473 (produced before May 14, 2014)

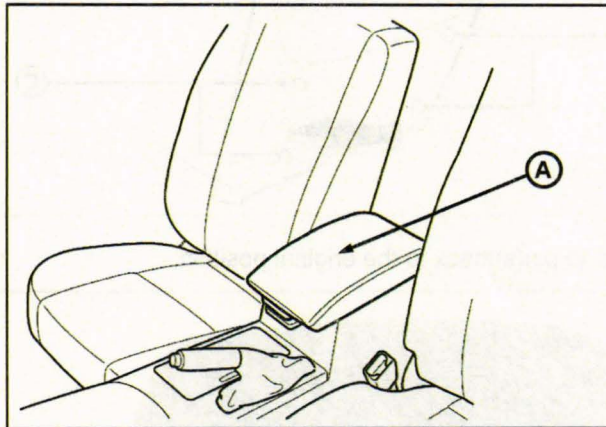
Some customers may complain about a loose rear console lid (A).

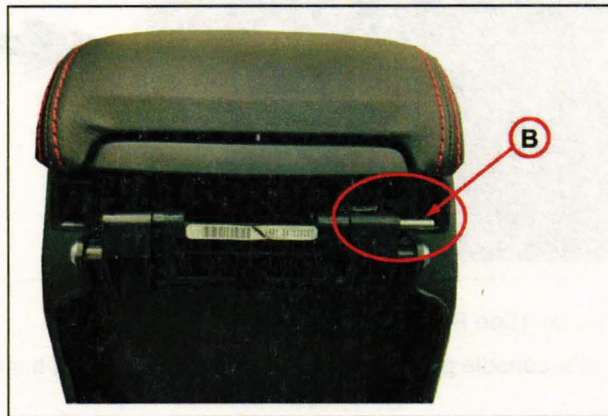
This may be caused by hinge pins coming partially off (B) or completely off.

NOTE: The shape of the rear console panel has been changed, by adding a stopper rib to prevent the pin from coming off.
