09-045/14 - 2014-2015 MAZDA6 - REAR CONSOLE LID IS LOOSE

Service Bulletin

Subject: REAR CONSOLE LID IS LOOSE	Bulletin No: 09-045/14
	Last Issued: 11/24/2014

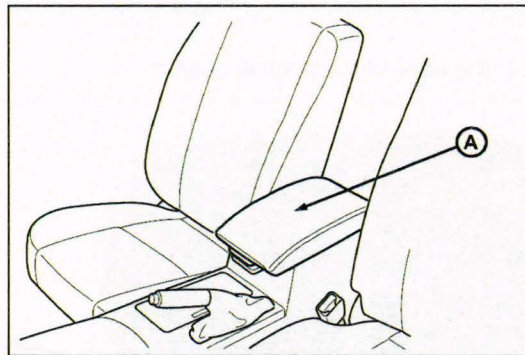
Some customers may complain about a loose rear console lid (A).

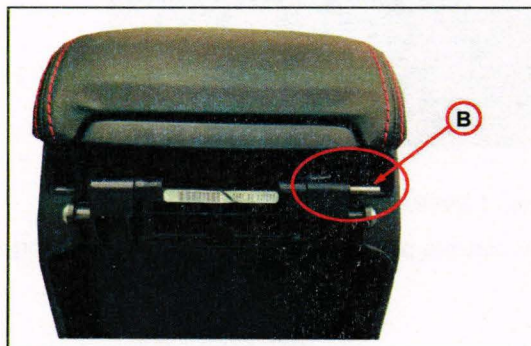
This may be caused by hinge pins coming partially off (B) or completely off.

NOTE: The shape of the rear console panel has been changed, by adding a stopper rib to prevent the pin from coming off.
