| Subject: MAZDA CONNECT CLOCK DISPLAYS TIME OF INCORRECT TIME ZONE WHEN GPS SYNC IS ON | Bulletin No: 09-046/14 |
| | Last Issued: 10/28/2014 |

2014-15 Mazda3 vehicles (with MAZDA CONNECT)

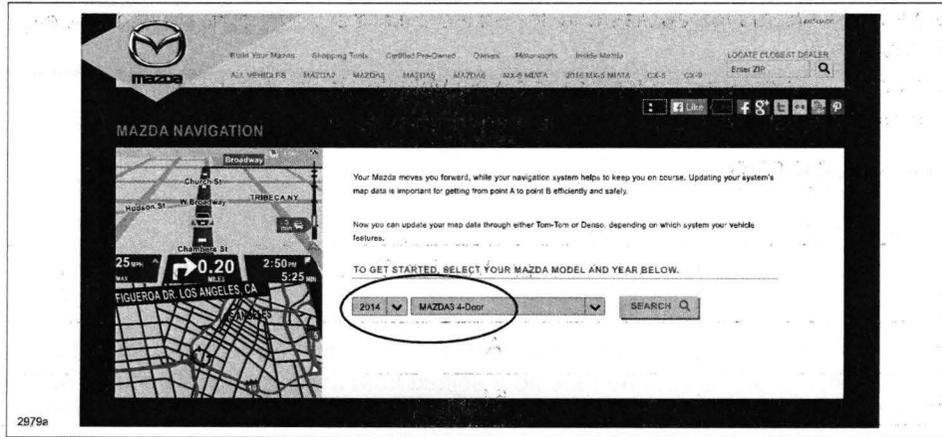
a. Select the year and model.

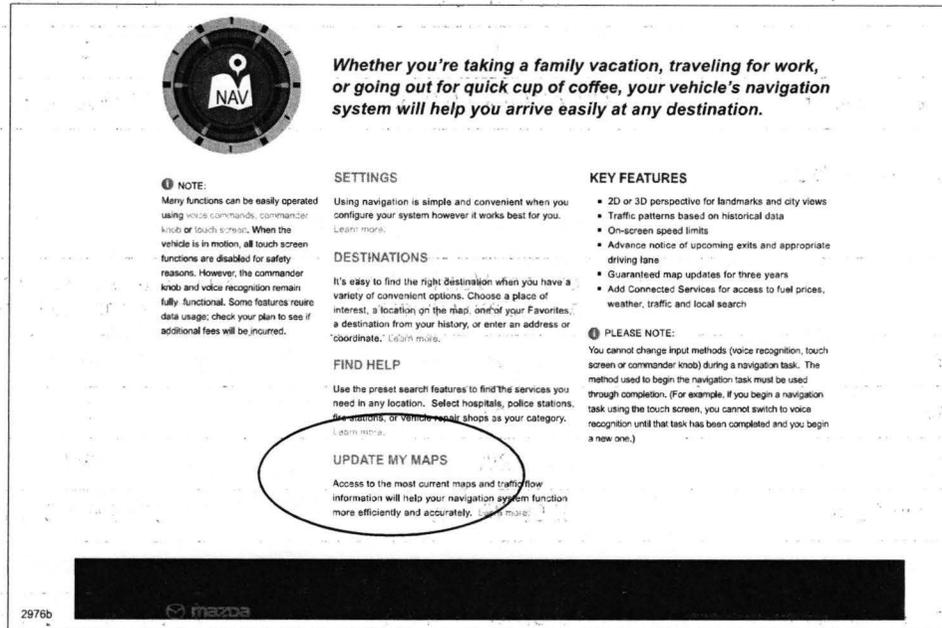
b. Select "UPDATE MY MAPS."
