SERVICE BULLETIN RELEASE - 11/04/2014

Subject: CLOCK RESETS TO 1:00 BY ITSELF AND / OR DISPLAY IS BLANK / FREEZES	Bulletin No: 09-047/14
	Last Issued: 11/4/2014

2014-2015 Mazda6 vehicles (with Automatic Climate Control) with VINs lower than JM1 GJ ***** 210201 (produced before September 22, 2014)

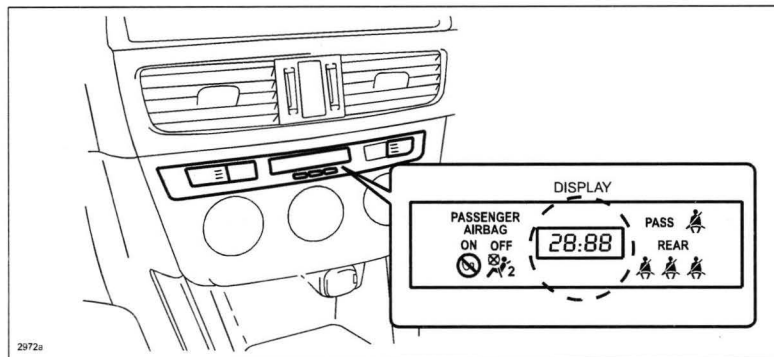
- The clock resets to 1:00 by itself.
- The clock display is blank.
- The clock display freezes.
- The clock displays a wrong time.

Internal failure of the climate control unit may be the cause.

1. Verify customer concern.
2. Replace the climate control unit. Refer to MS3 online or Workshop Manual (section 07-40 CLIMATE CONTROL UNIT REMOVAL/INSTALLATION [FULL-AUTO AIR CONDITIONER]).
3. Verify repair.
