Technical Service Bulletin

14-AT-004

MODEL
SONATA (YF HEV)

EV MOTOR TEMPERATURE SENSOR DTC P0A2B, P0A2C, P0A2D & P0A2F

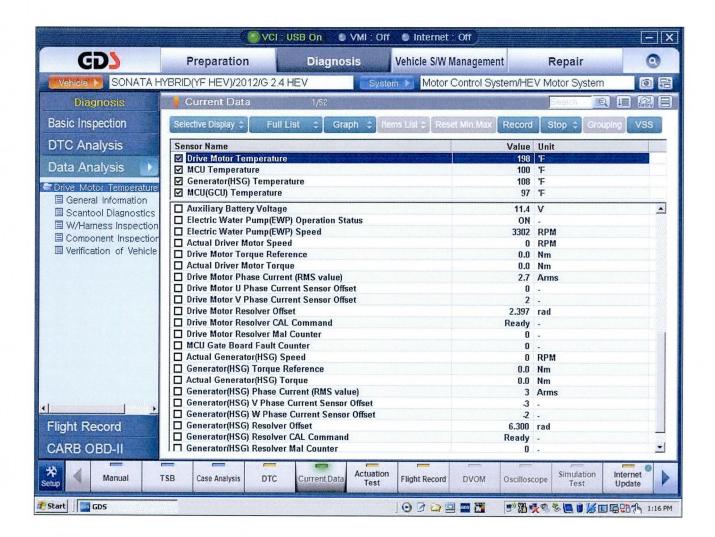
A Drive Motor Temperature of 417°F indicates a fault in the motor temperature circuit.

Confirm the drive motor temperature is within specification according to the chart below. Turn "EV ready" off.

Go to Step 3 to continue the diagnosis.

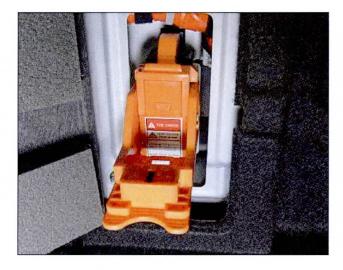
Failure to perform this procedure may result in accidental injury or death.

Open the rear trunk and open the cover to the safety switch.

Put on safety gloves and pull up on the black tab and pull out the safety switch.
