HYUNDAI NEW THINKING. NEW POSSIBILITIES. Technical Service Bulletin	GROUP FUEL SYSTEM	NUMBER 14-FL-005
	DATE OCTOBER, 2014	MODEL(S) GENESIS COUPE (BK)
SUBJECT: ECM UPDATE – GENESIS COUPE 2.0L TURBO MIL ON (DTC P050B)

SUBJECT: ECM UPDATE – GENESIS COUPE 2.0L TURBO MIL ON (DTC P050B)

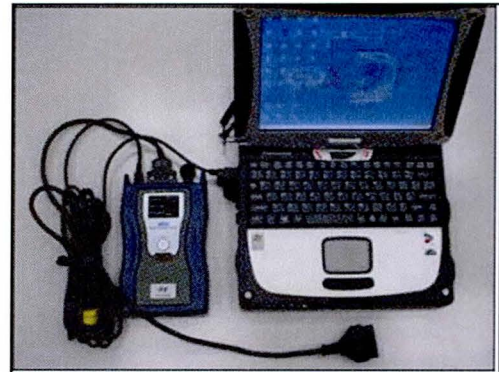
- Connect the USB cable between the GDS and the VCI.
- Connect the 16-pin DLC connector from the VCI into the DLC located under the driver's side dash.

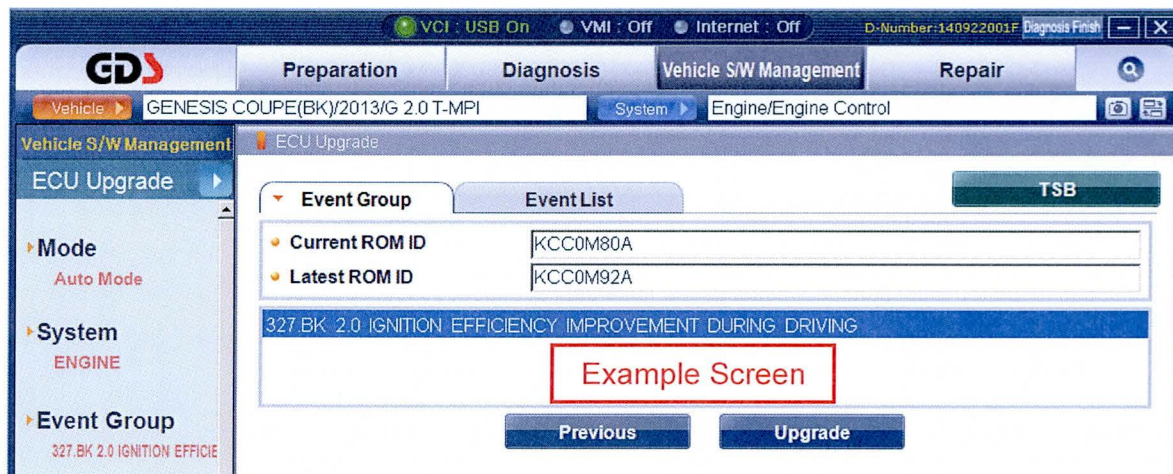
5. Select update event as listed on the **GDS Event list of page-1**. Select **Upgrade**.
