Driver Seat - LH Rear Bolt Cover Deformation

Service
 Category Vehicle Interior

Section Seat

YEAR(S)	MODEL(S)	ADDITIONAL INFORMATION
2014	Tundra

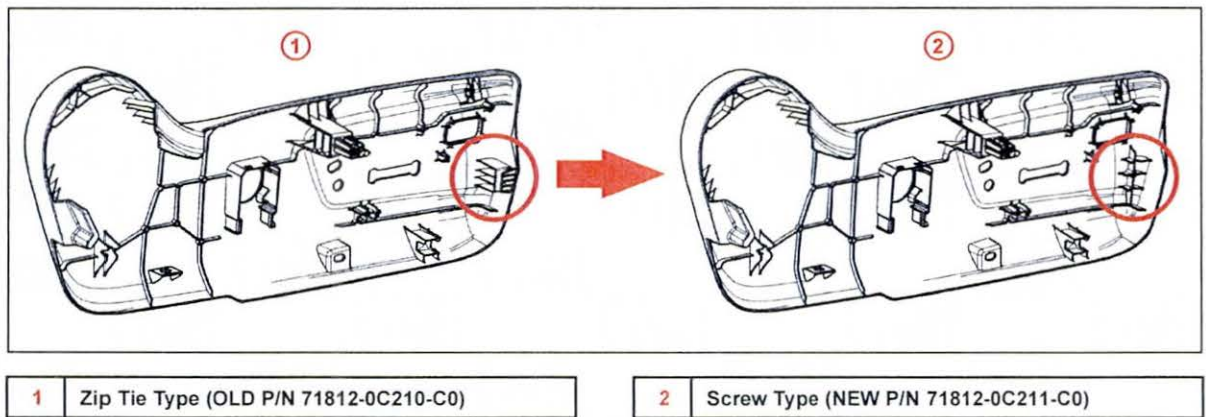
Figure 1. Front Seat Cushion Shield LH

Some 2014 model year CrewMax and Double Cab Tundra vehicles may exhibit a condition where the driver's left rear seat track cover is being caught by the seat side shield, causing the seat track cover to bend backwards when the seat is in the rearmost position. Follow the procedures in this bulletin to address this condition.

- 2014 Tundra:
Vehicle Interior – Seat – “Seat: Front Seat Assembly (for Power Seat): [Removal](#)”
2. Replace the original Front Seat Cushion Shield LH (zip tie type) with the NEW Front Seat Cushion Shield LH (screw type) and Front Seat Cushion Shield Wire LH.

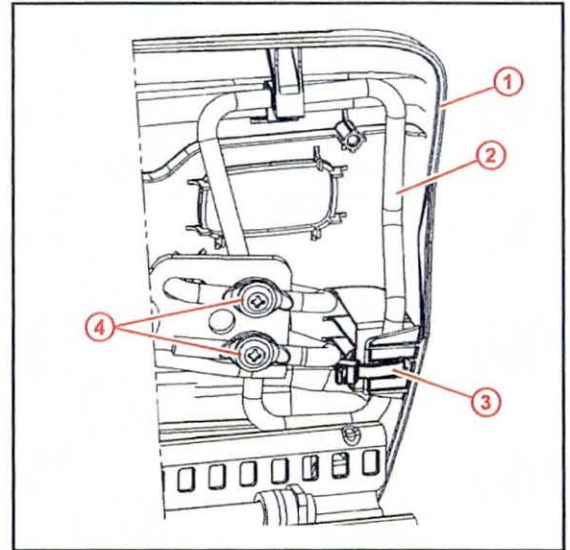
Figure 2.

1	Side Shield
2	Wire
3	Zip Tie
4	Wire Attachment Screws

A. Remove the side shield (zip tie may be cut).

B. Remove the Front Seat Cushion Shield Wire LH from the frame by removing the 2 wire attachment screws.

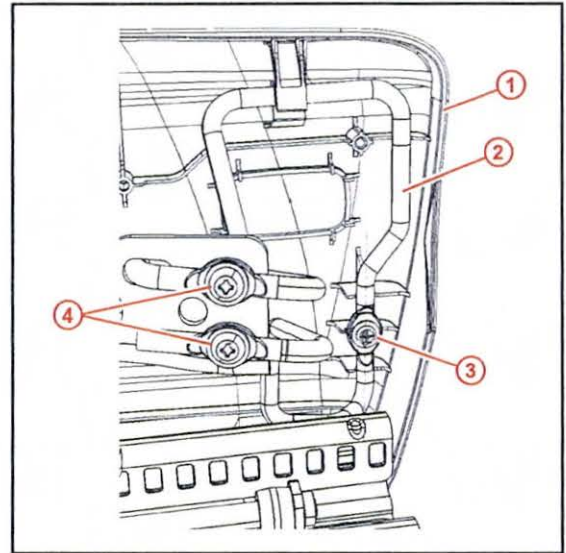
Figure 3.

1	NEW Side Shield
2	NEW Wire
3	NEW Screw (P/N 90080-16089)
4	Wire Attachment Screws

- C. Attach the NEW Front Seat Cushion Shield Wire LH.

- D. Attach the NEW side shield screw.
3. Replace the original Outer Rear Seat Track Bracket Cover LH with the NEW Outer Rear Seat Track Bracket Cover LH.

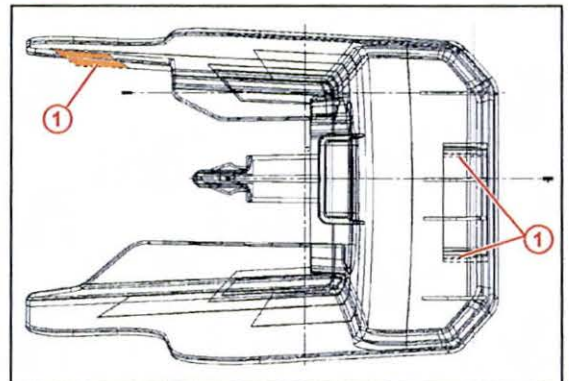
Figure 4.

The rib on the new cover is longer than the original part by 15 mm.

1	Outer Rear Seat Track Bracket Cover LH
---	--
