**SERVICE BULLETIN RELEASE - 04/01/2014**

01-008/14 – 2013-2015 CX-5 - CHECK ENGINE LIGHT ON WITH DTC P0452:00 AND/OR P0453:00

<b>Subject:</b> CHECK ENGINE LIGHT ON WITH DTC P0452:00 AND/OR P0453:00	<b>Bulletin No:</b> 01-008/14
	<b>Last Issued:</b> 04/01/2014

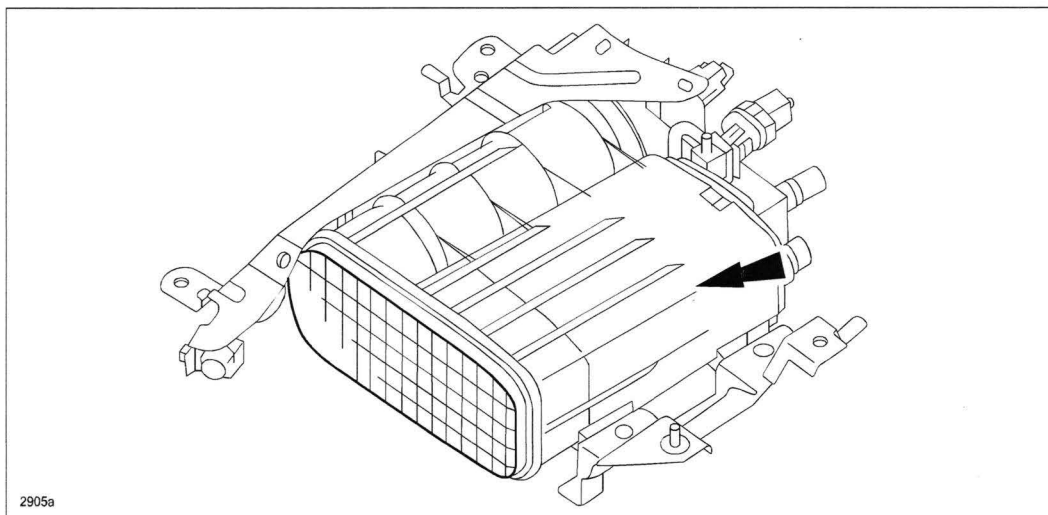
This concern may be caused by ants entering the FTP sensor through an opening (to atmosphere). The ants bite and eventually damage the wiring, which results in an improper FTP sensor output.

To eliminate this concern, the inside of the opening pipe (to atmosphere) has been modified to prevent ants from entering.

1. Verify the customer concern.
2. Replace the charcoal canister assembly (includes FTP sensor) with a modified part according to the instructions on MS3 online or the Workshop Manual (section 01-16 CHARCOAL CANISTER REMOVAL/INSTALLATION [SKYACTIV-G 2.0, SKYACTIV-G 2.5]).
