SERVICE BULLETIN RELEASE - 04/07/2014

01-010/14 – MULTI-MODEL (WITH SKYACTIV 2.0L/2.5L) - MIL ON WITH DTC P0191:00

Subject: MIL ON WITH DTC P0191:00	Bulletin No: 01-010/14
	Last Issued: 04/07/2014

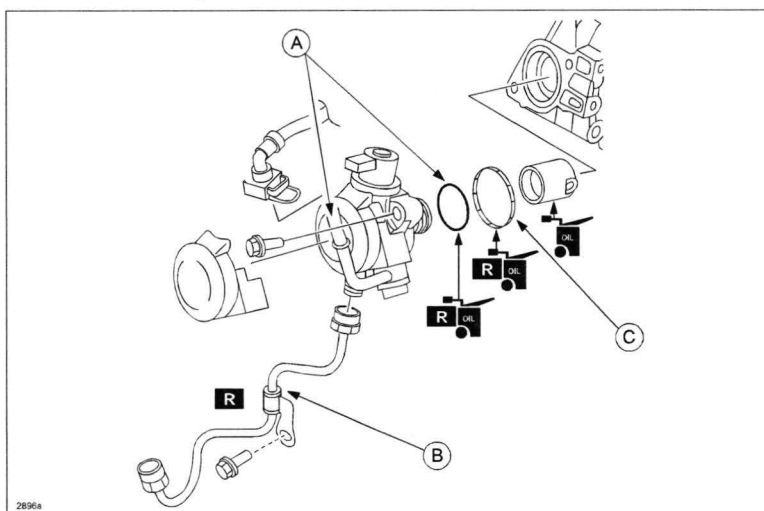
Some vehicles may experience the MIL on with DTC P0191:00 (Fuel pressure sensor circuit range/performance problem) stored in memory. This is caused by the high pressure fuel pump not generating the target fuel pressure (due to a manufacturing error of the inner parts). To correct the problem, production control has been improved.

1. Verify customer concern.
2. Replace the high pressure fuel pump with a modified one according to the Workshop Manual.
3. Replace the high pressure fuel pump (A: fuel pump; B: fuel pipe; C: rubber seal) with a modified one according to the instructions on MS3 online or the Workshop Manual (section 01-14 HIGH PRESSURE FUEL PUMP REMOVAL/INSTALLATION).
