01-010/14 – MULTI-MODEL (WITH SKYACTIV 2.0L/2.5L) - MIL ON WITH DTC P0191:00 OR P0192:00

Service Bulletin

Subject: CHECK ENGINE LIGHT ON WITH DTC P0191:00 OR P0192:00	Bulletin No: 01-010/14
	Last Issued: 04/29/2014

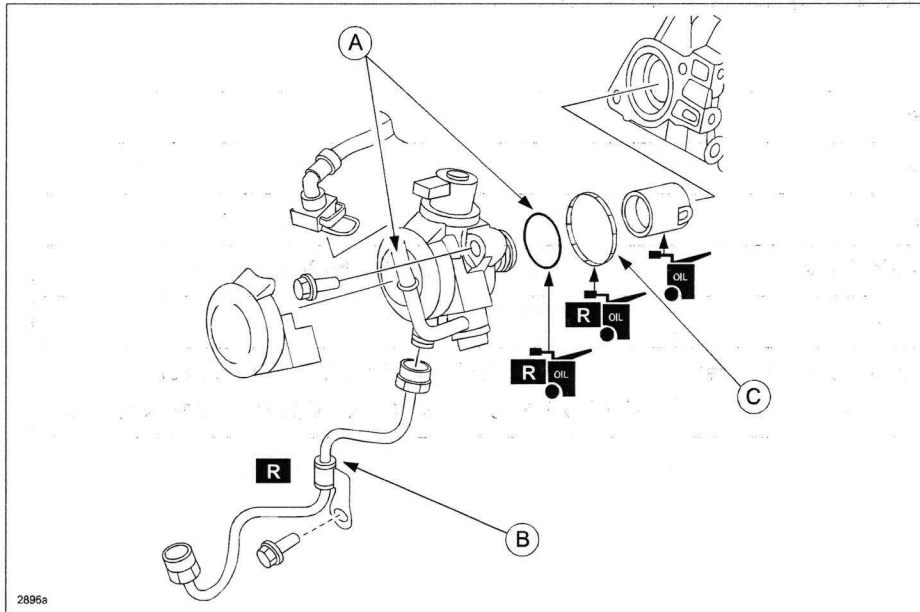
This is caused by the high pressure fuel pump not generating the target fuel pressure (due to a manufacturing error of the inner parts). To correct the problem, production control has been improved.

1. Verify customer concern.
2. Replace the high pressure fuel pump with a modified one according to the Workshop Manual.
3. Replace the high pressure fuel pump (A: fuel pump; B: fuel pipe; C: rubber seal) with a modified one according to the instructions on MS3 online or the Workshop Manual (section 01-14 HIGH PRESSURE FUEL PUMP REMOVAL/INSTALLATION).
