01-011/14 – 2007-2012 CX-7 - CLUNKING NOISE FROM NO. 3 ENGINE MOUNT

Subject: CLUNKING NOISE FROM NO. 3 ENGINE MOUNT	Bulletin No: 01-011/14
	Last Issued: 04/15/2014

2007-2012 CX-7

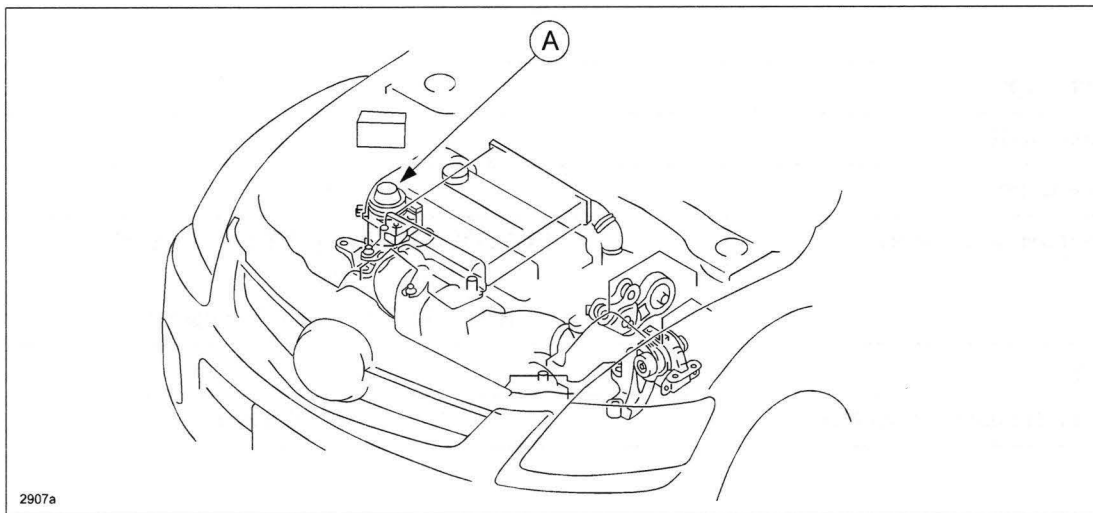
Some vehicles may exhibit a clunk noise from the engine compartment when driving over rough roads or over a speed bump. The noise may occur in areas of high ambient temperatures.

Due to high heat, the lubricant inside the No. 3 engine mount rubber (A) may become ineffective, causing a stick-slip noise between the casing and the rubber, however, there is no seepage from the engine mount.

The engine mount rubber uses a new type of lubricant to eliminate this concern.

Customers having this concern should have their vehicle repaired using the following repair procedure.

1. Verify the customer concern.
2. Replace the No. 3 engine mount according to the instructions on MS3 online or the Workshop Manual: (CX-7 2.3L (L3 Turbo) Engine, section 01-10 NO. 3 ENGINE MOUNT DISASSEMBLY/ASSEMBLY) or (CX-7 2.5L (L5) Engine, section 01-10 NO. 3 ENGINE MOUNT DISASSEMBLY/ASSEMBLY).
3. Verify the repair.
