OIL SEEPAGE FROM JOINT SHAFT

Bulletin No: 03-001/14

Last Issued: 05/05/2014

2010-**2013** Mazda3

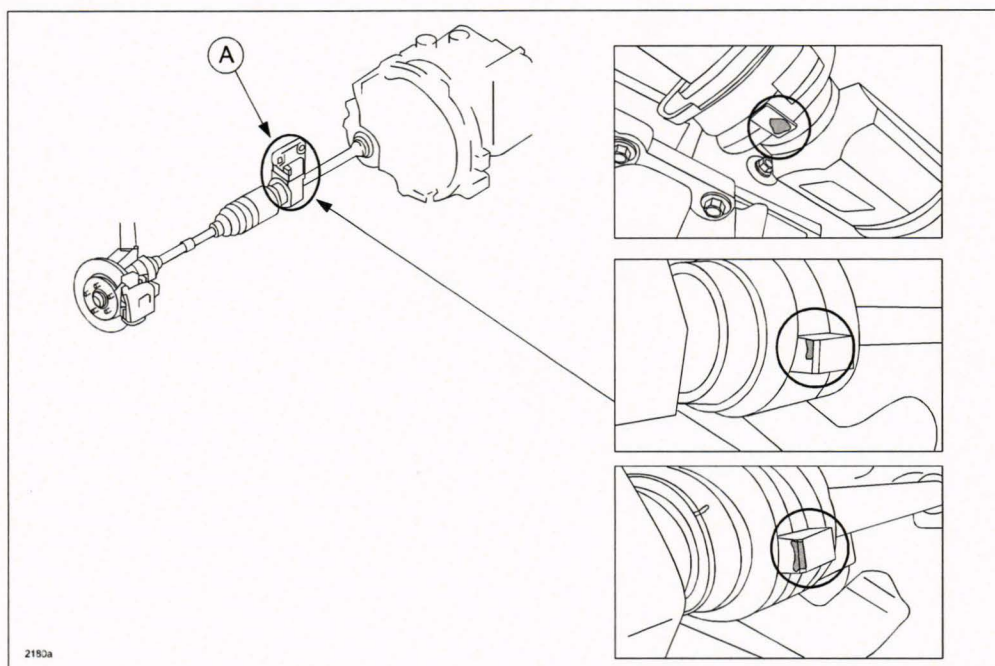
Some new vehicles may exhibit oil seepage underneath the bearing bracket (A) on the right side of the joint shaft. This is caused by the oil content separating from the grease applied to the bearing and spline seeping from the seal and bracket.

There is no functional problem with this issue since the amount of oil seepage is very small compared to the amount of grease. Note that the oil seepage will stop while the vehicle is in use.

If you encounter a customer complaint about this concern, wipe off the oil with a rag. DO NOT replace the joint shaft.
