SERVICE BULLETIN RELEASE - 07/16/2014

03-003/14 – MULTI-MODEL - GROAN NOISE FROM FRONT WHEEL HUB

Subject: GROAN NOISE FROM FRONT WHEEL HUB	Bulletin No: 03-003/14
	Last Issued: 07/16/2014

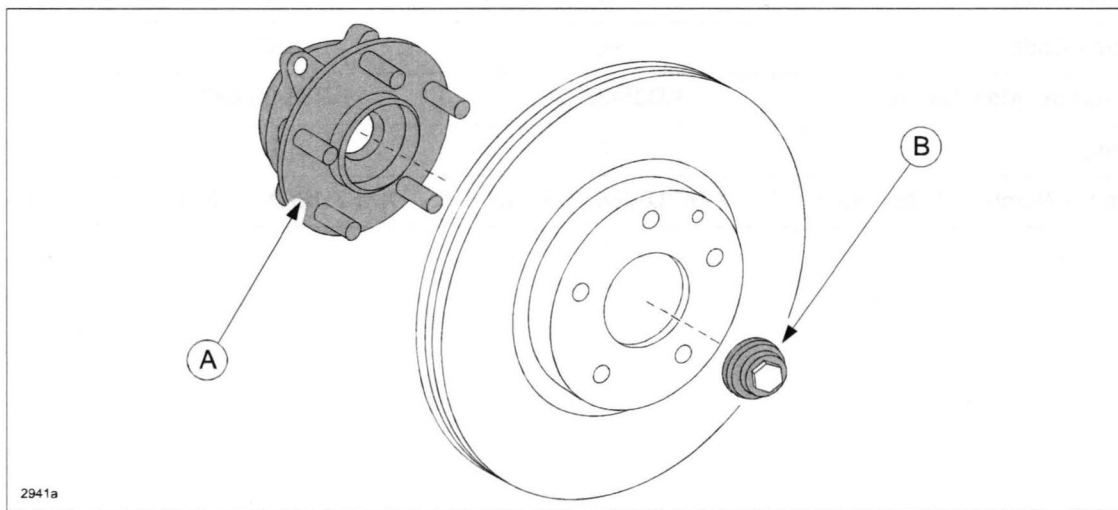
Some vehicles may exhibit a groan type noise from the front wheel hub bearing while driving at high speed or when cornering. This may be caused by front wheel hub bearing corrosion.

1. Verify customer concern.
2. Replace the affected front wheel hub (A) and locknut (B). Refer to MS3 online or Workshop Manual (section 03-12) removal/installation instructions for the front wheel hub and the locknut only.
 - CX-5 - WHEEL HUB COMPONENT REMOVAL/INSTALLATION [AWD]
 - Mazda6 - WHEEL HUB, STEERING KNUCKLE REMOVAL/INSTALLATION
