Subject: RATTLE NOISE FROM REAR BRAKE CALIPER	Bulletin No: 04-001/14
	Last Issued: 1/8/2014

2014 Mazda6 vehicles with VINs lower than JM1 GJ ***** 149693 (produced before October 03, 2013)

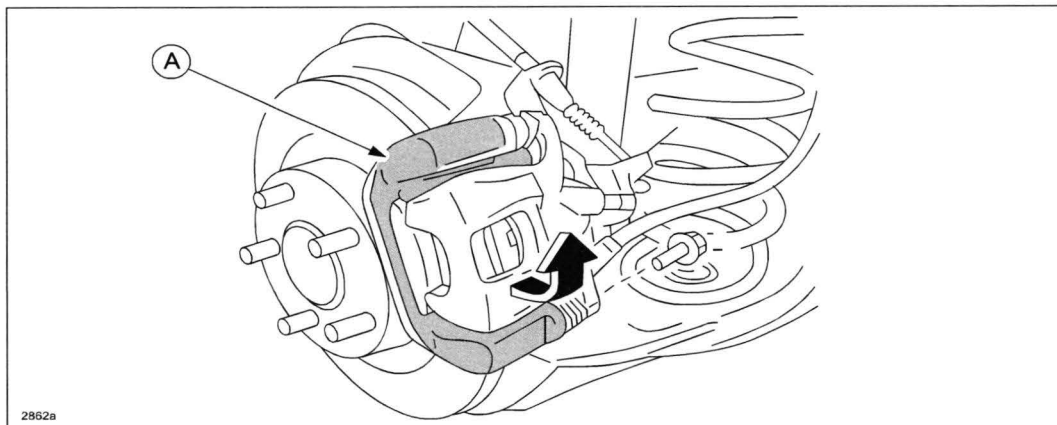
A rattle noise may be heard from the rear part of the vehicle when driving on rough roads. If the driver puts his/her foot on the brake pedal, the noise disappears. The rear brake pad(s) may be moving inside the caliper(s), causing a rattling noise.

1. Verify customer concern.
2. When noise is present, lightly depress the brake pedal. Does the noise disappear?
 - a. Yes - Proceed to Step 3.
 - b. No - This bulletin does not apply. Proceed to step 4.
3. Replace the rear brake caliper mounting support (A) and brake pad shim and retainer at the affected side. Refer to MS3 online or Workshop Manual (section 04-11 REAR BRAKE (DISC) REMOVAL/INSTALLATION). Then proceed to step 5.
