Service Bulletin

Subject: SQUEAKING / GRINDING NOISE FROM REAR BRAKES	Bulletin No: 04-003/14
	Last Issued: 02/04/2014

2013-2014 CX-5 with VINs lower than JM3 KE*****401869 (produced before Oct. 9, 2013)

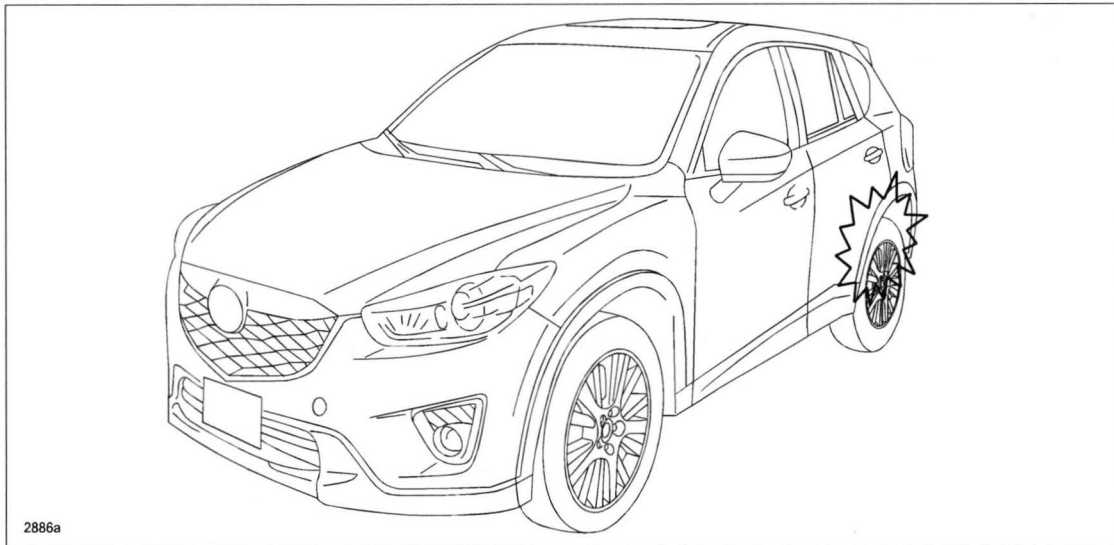
Some vehicles may exhibit a squeaking / grinding noise from the rear brakes. This noise may be caused by the wear indicators of prematurely worn **outer** rear brake pads.

NOTE: The inner rear brake pads will only show a little wear. This condition only affects the outer rear brake pad(s).

During usage of the vehicle in areas where road salt is used, the **outer** rear brake pad(s) may become stuck due to corrosion. This may cause brake dragging and premature wear to the **outer brake pad(s) only**.

The treatment of the brake pad back plate has been changed to eliminate this concern.
